*Dauphin County Gaming Advisory Board
Pennsylvania*

Comprehensive Review of Fire and
Emergency Service Resources
Final

December 2011

Comprehensive Review of Fire and Emergency Service Resources

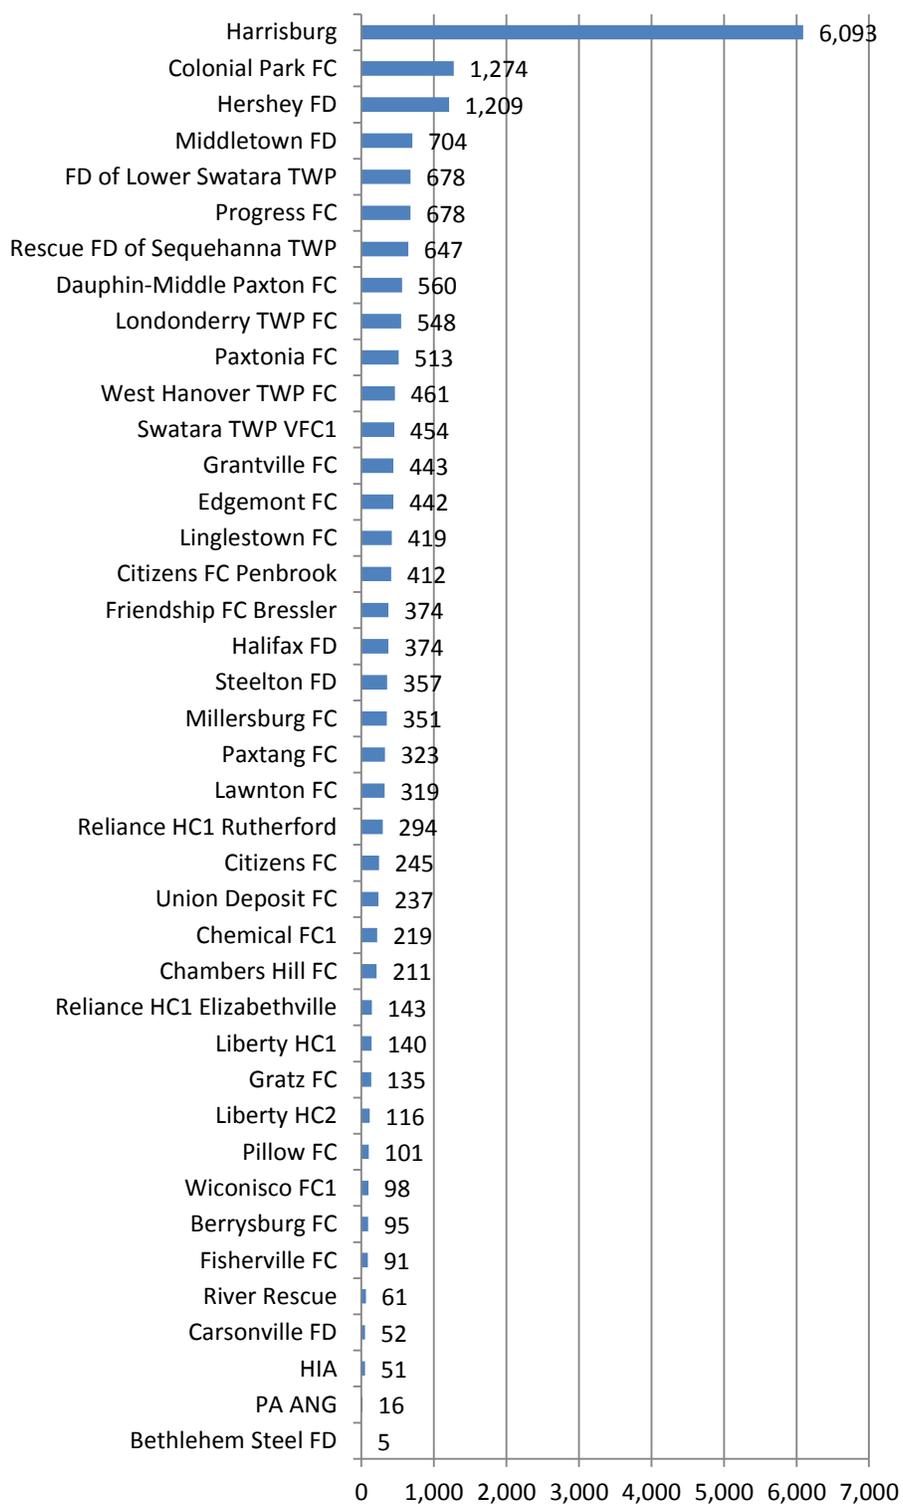
Figure 1: Service Demand by Department: 7/1/2009 – 6/30/2010

Demand is defined as the amount of workload an individual agency is receiving. In regards to Dauphin County, demand was evaluated by station in order to develop a full picture of how service demand was distributed across the various agencies and physical resources. The following figure illustrates the service demand experienced by each agency during the July 1, 2009, to June 30, 2010, time period.

As illustrated in the previous figure, Harrisburg Bureau of Fire is the busiest of all Dauphin County fire service agencies, as would be expected. HFD's service demand is combined since the department operates on a multiple station response protocol for most incidents.

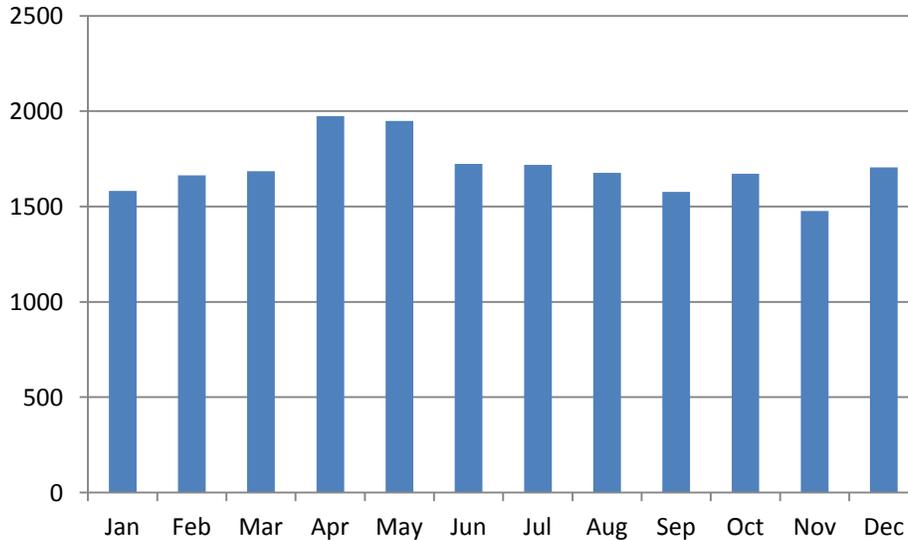
Figure 2: Service Demand by Month

Analysis of service demand by month indicates that the busiest months for all providers within Dauphin County are April and May. This corresponds to the spring months when the general population begins to become more active. Analysis continues with an evaluation of service demand by day of week.

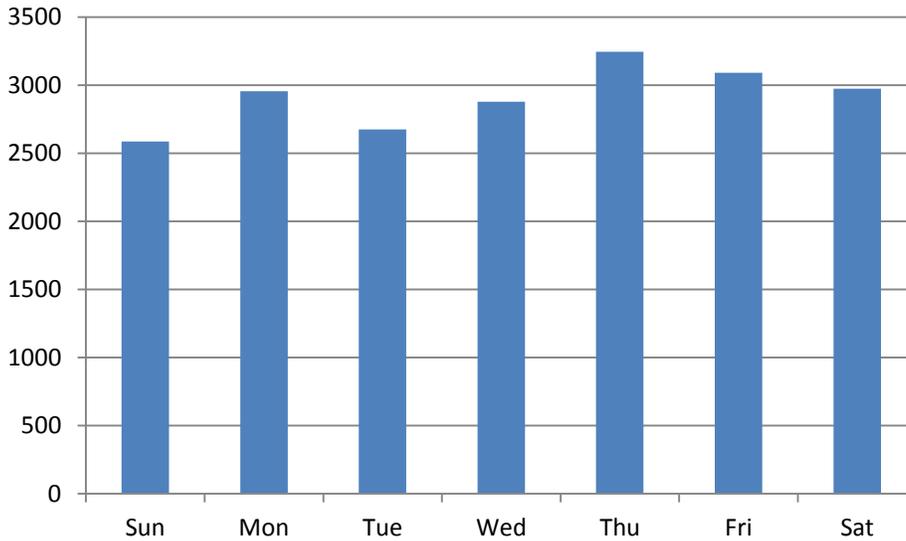
Figure 3: Service Demand by Day of Week

Temporal analysis of Dauphin County’s service demand by day of week indicates that workload is highest on Thursdays with Fridays and Saturdays trending higher than the rest of week as well. This suggests that the general population is more active during periods late in the week and early in the weekend. The final temporal analysis evaluates service demand by hour of day.

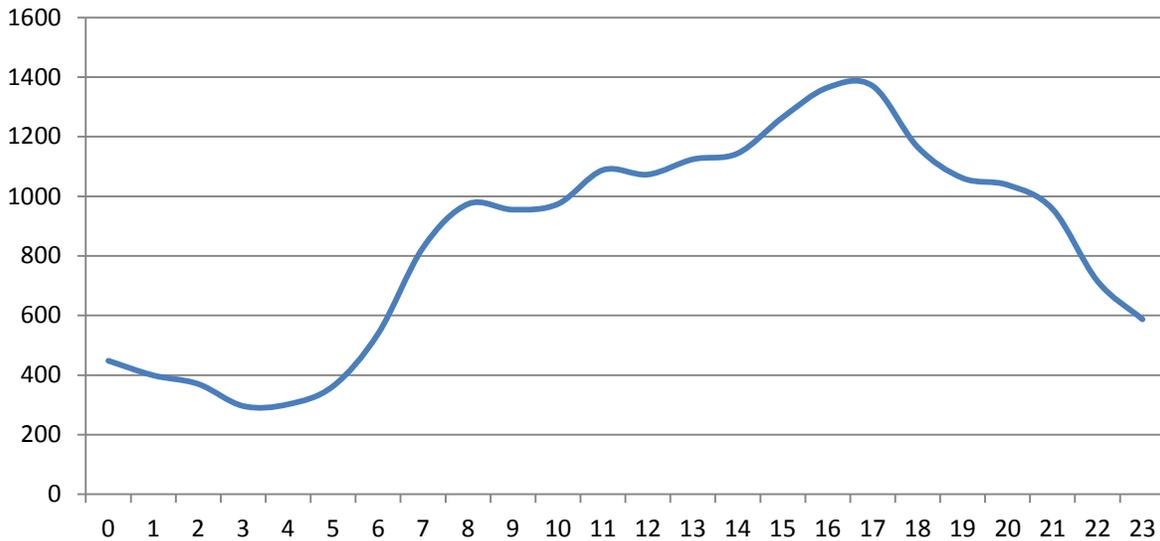
Figure 4: Service Demand by Hour of Day

As with most emergency services providers, Dauphin County’s emergency services demand is lowest during the overnight hours and begins to increase between 5:00 and 6:00 a.m., peaking in the late

afternoon before tailing off into the evening hours. This typical bell curve representation is indicative of normal human activity, which greatly influences fire and EMS service demand.

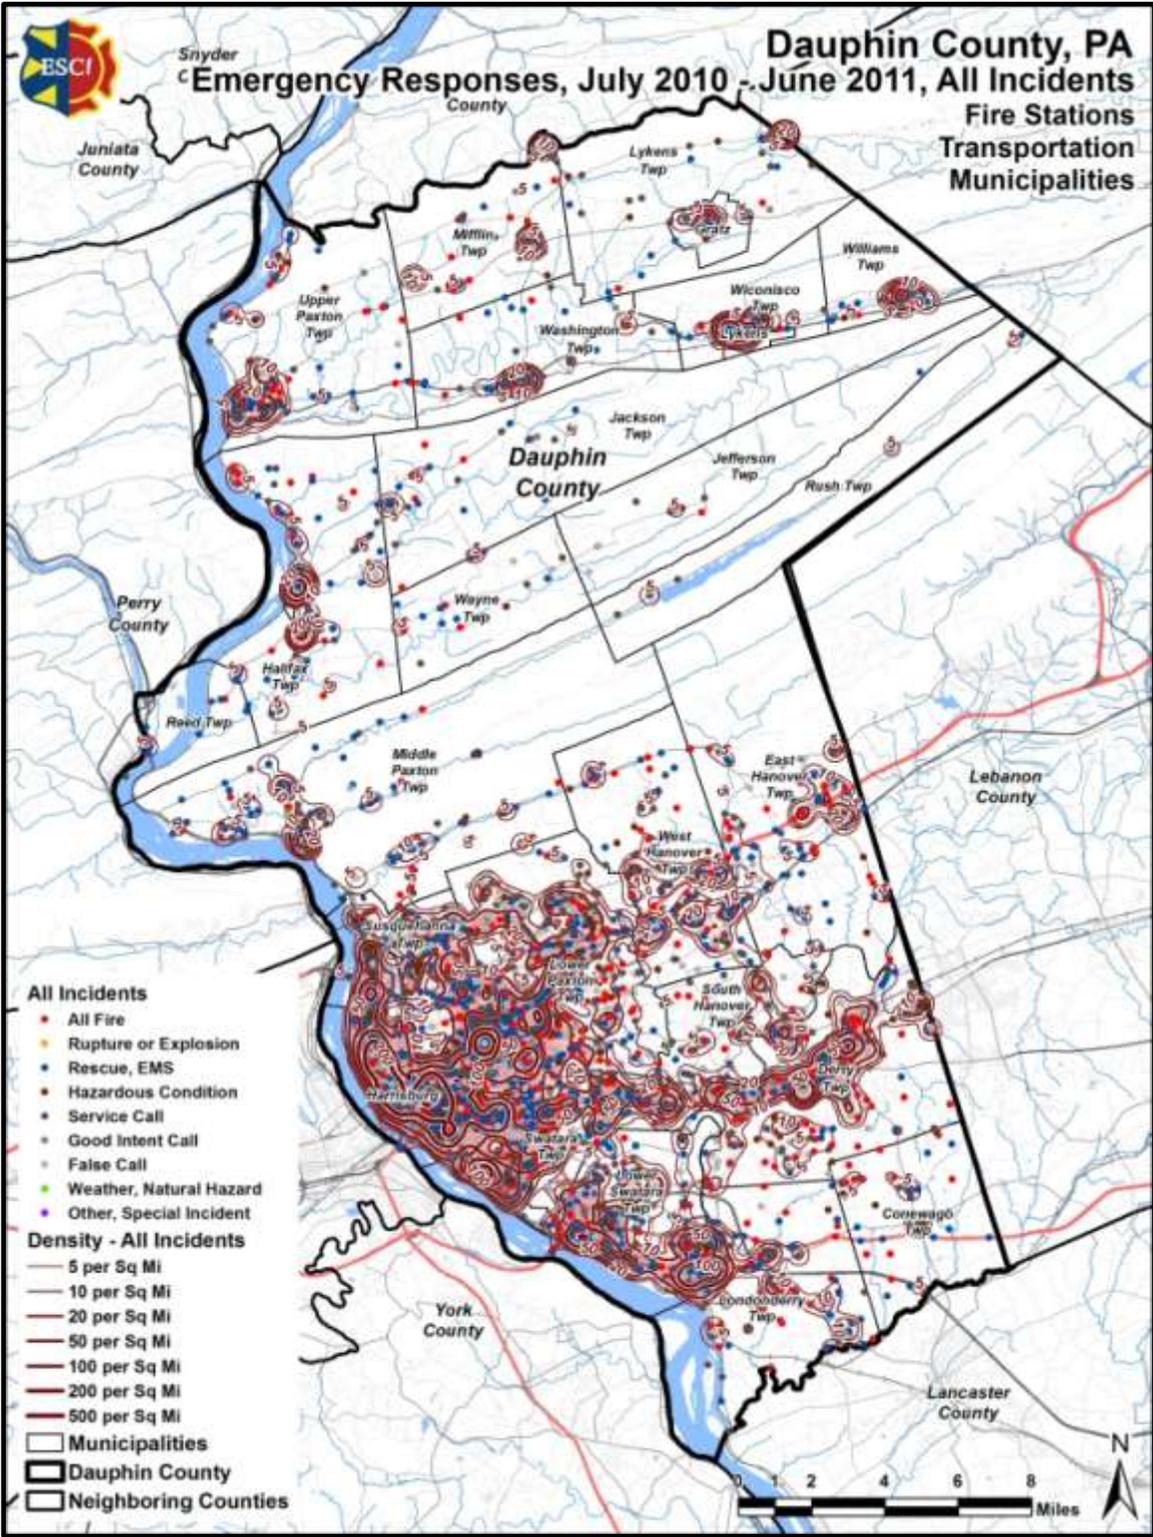
Figure 5: Geographic Service Demand

Another mechanism by which to evaluate service demand is geographical distribution of workload. By evaluating where incidents are occurring in relation to current physical resources (stations and apparatus), determinations can be made regarding the need for additional resources, redundancies of resources, and the establishment of response performance objectives based on level of service expectations. The following figure illustrates the total service demand within Dauphin County for the year of data provided.

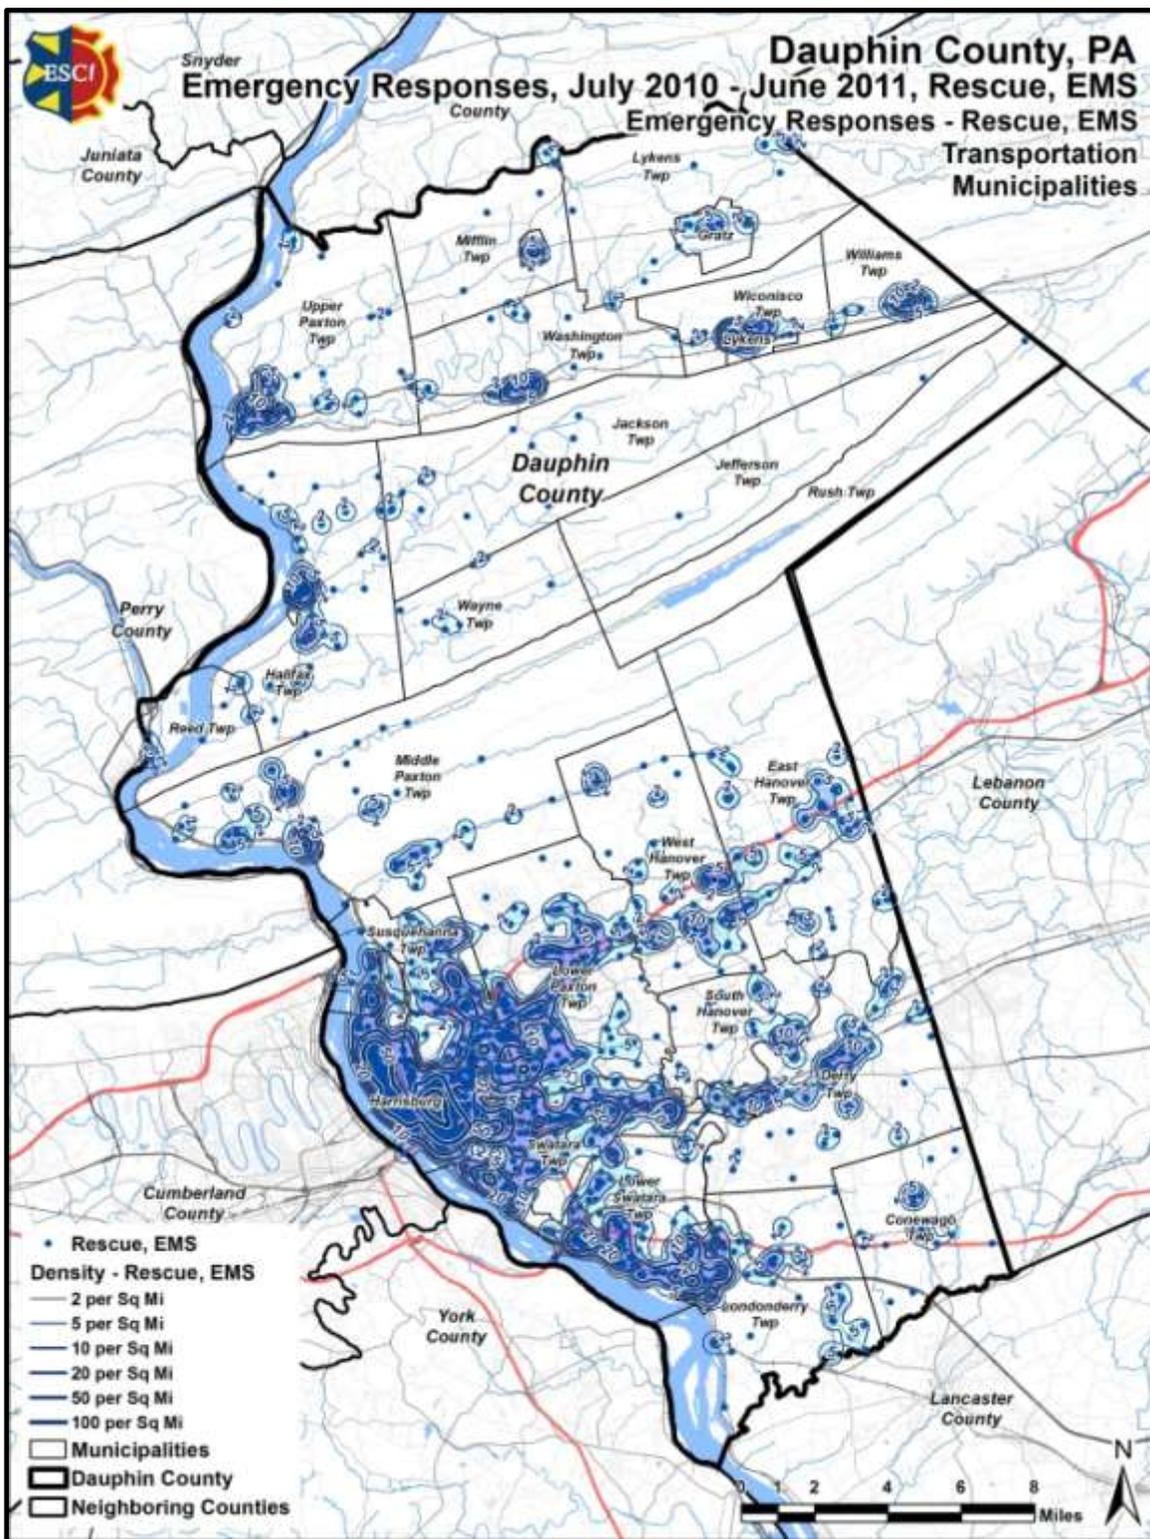
Figure 6: Geographic Distribution of Medical and Rescue Incidents

distribution of service demand in a given area. The following map illustrates the geographical distribution of medical and rescue incidents that have a significant impact on the emergency services system within Dauphin County.

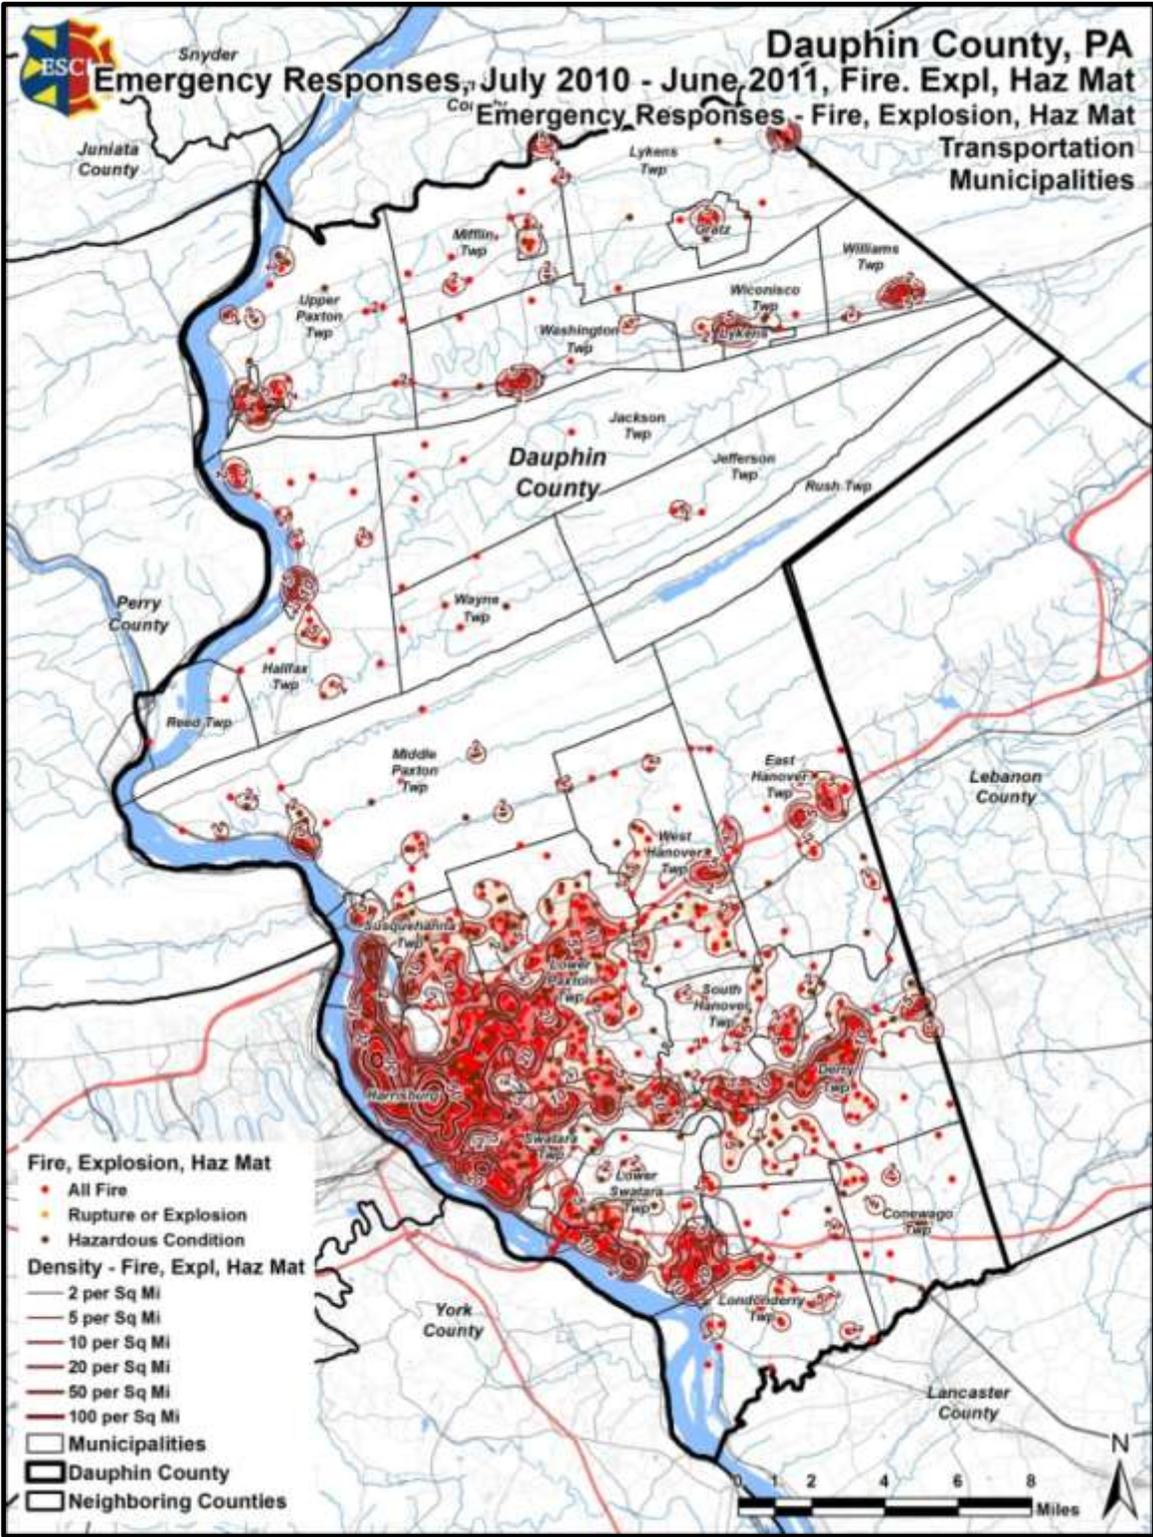
Figure 7: Geographic Distribution of Fire Incidents

Likewise, the most visible impact a fire department can have on a community is its quick response and effective mitigation of structure fires. The following figure illustrates the geographic distribution of fires throughout Dauphin County during the one year of data provided.

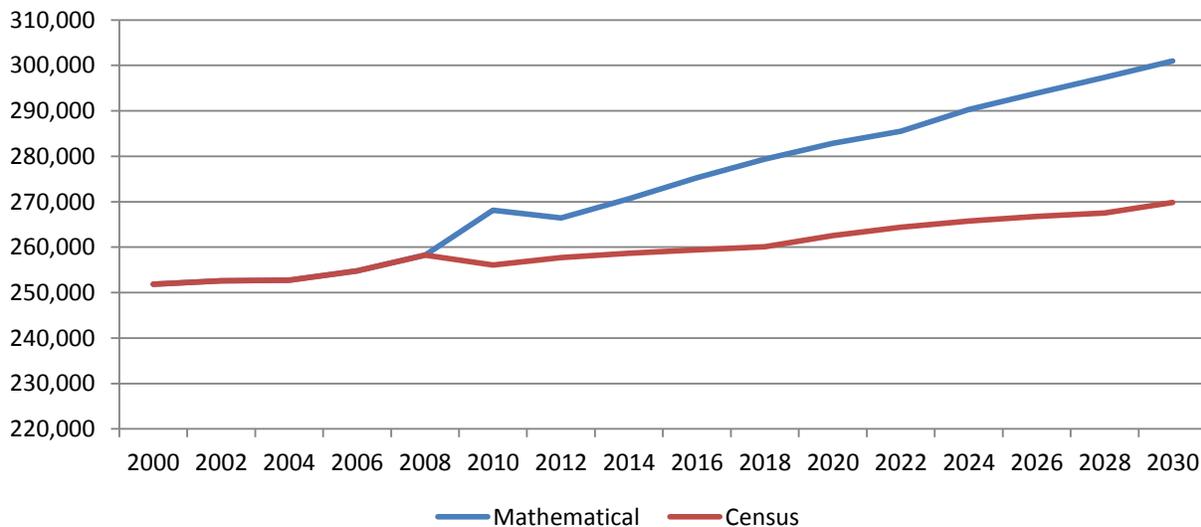
Figure 8: Population Forecast

ESCI typically develops a forecast for future service demand based on several decades of census experience. In the case of Dauphin County, decennial census figures from 2000 through 2010 were used to generate a mathematical forecast through 2030. Based on the latest census data available, Dauphin County's 2010 population exceeded previous projections by 12,030. This calls into question additional census population projections for the county. Thus, ESCI utilized basic forecasting tools to project biannual population estimates. The resulting population forecasts based on the mathematical forecast as well as census projections are illustrated in the figure below.

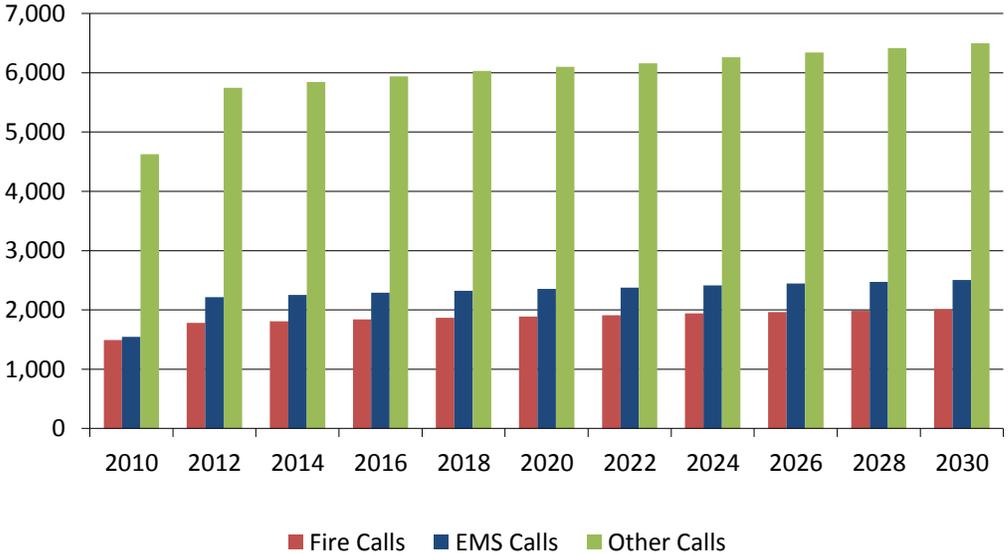
Figure 9: Future Service Demand Projections

Using this information, ESCI calculates a per-capita usage rate for emergency services and projects future service demand. Based on the population projections indicated previously, the figure below illustrates the potential service demand over the next 20 years within Dauphin County for both fire and EMS incidents.

As illustrated in the figure above, while fire and EMS incidents will remain relatively low, other responses such as alarms, odors, public assists, etc. will remain the most prevalent incident type. It should be noted, however, that only two years of historical incident data was submitted to ESCI for this analysis. Over that two year period, all incident types saw declines for the county as a whole. Therefore, an average incident rate was used to generate the future service demand projections, which could actually be lower given more complete historical incident information.

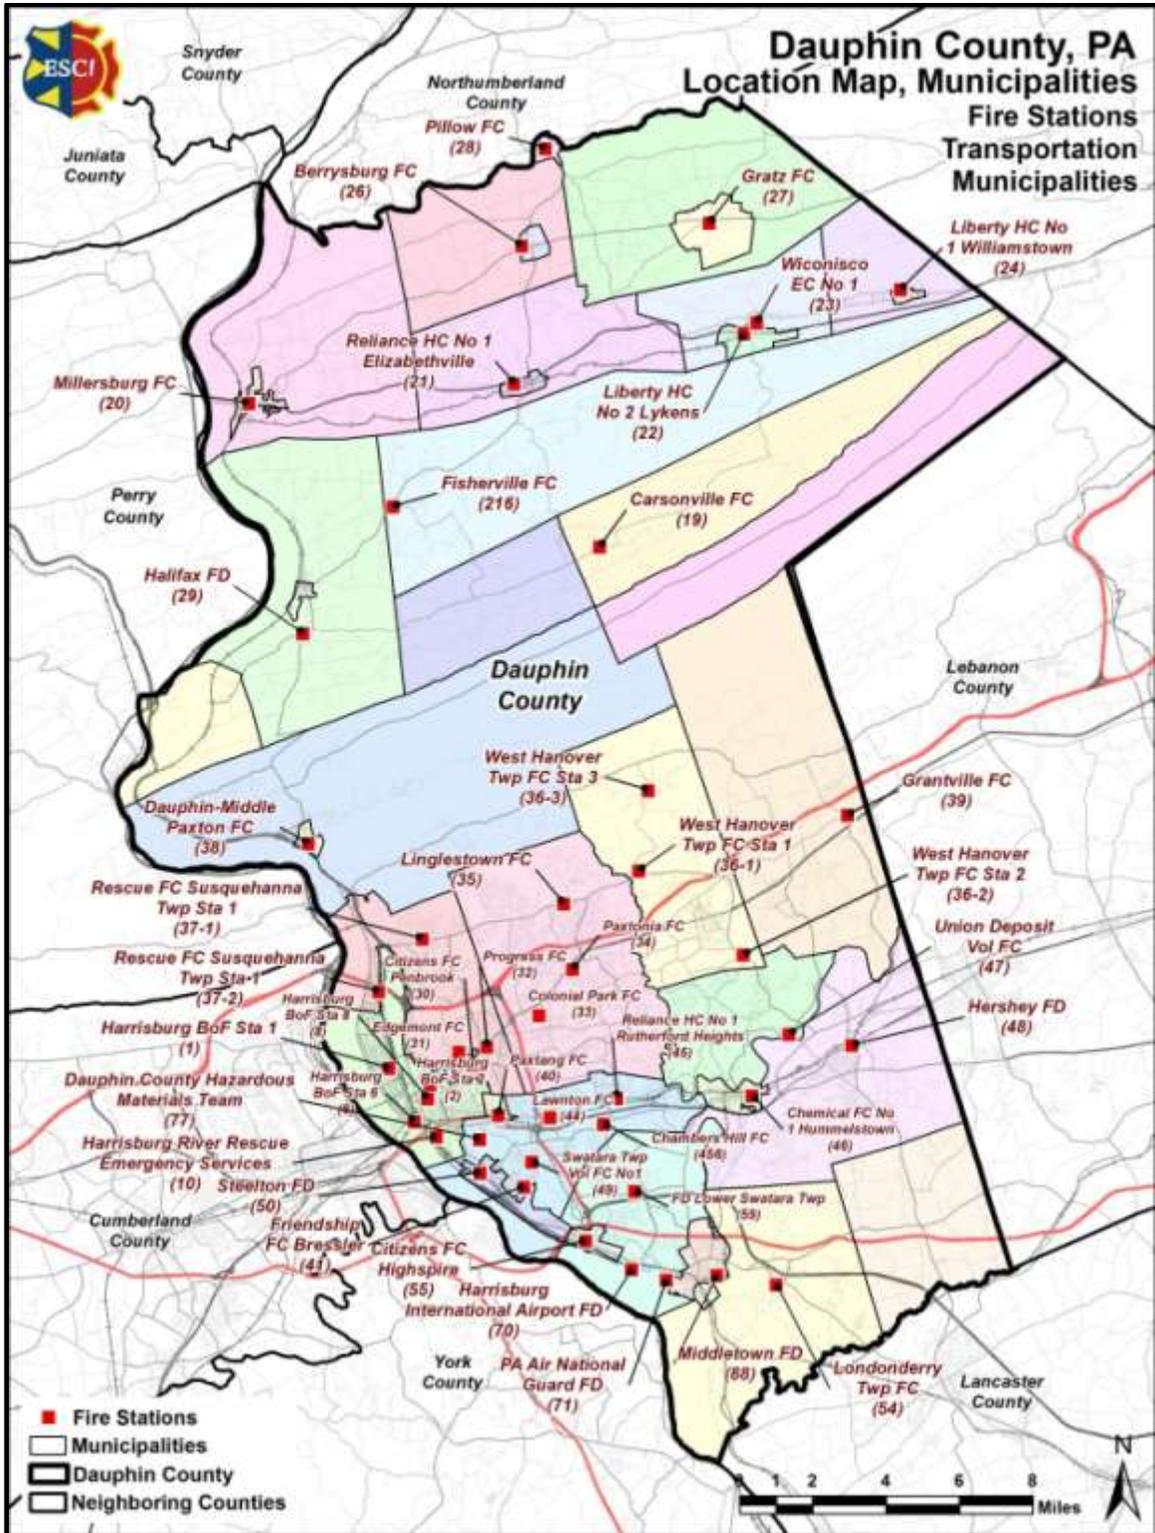
Figure 11: Geographic Service Area

The following figure illustrates the overall service area with individual fire district boundaries and the physical locations of each Dauphin County fire station.

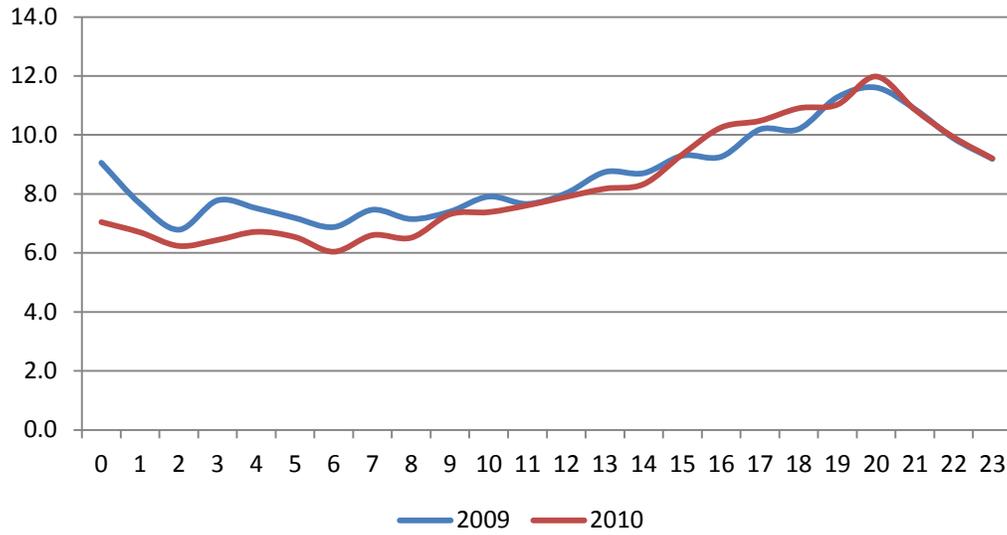
Figure 14: Staffing by Hour of Day

As with incident volume, which will be discussed later, availability of staffing varies by hour of day in departments that utilize volunteers to staff emergency units. This is illustrated in the following figure.

The preceding figure indicates that, during the hours between midnight and 12:00 p.m., staffing levels are at their lowest. This is to be expected in working class communities where volunteers typically have other jobs that are a priority over fire department response. As personnel leave work at the end of their shift or are allowed by their employer to leave for emergency responses, staffing increases and peaks around 8:00 p.m. This is representative of the county as a whole and includes static staffing of HFD. Since most incidents are not structure fires, high staffing numbers are not routinely necessary. However, structure fires, although infrequent, require more personnel to accomplish critical tasks and effectively mitigate the incident. The following figure illustrates the region’s staffing performance on only structure fires.

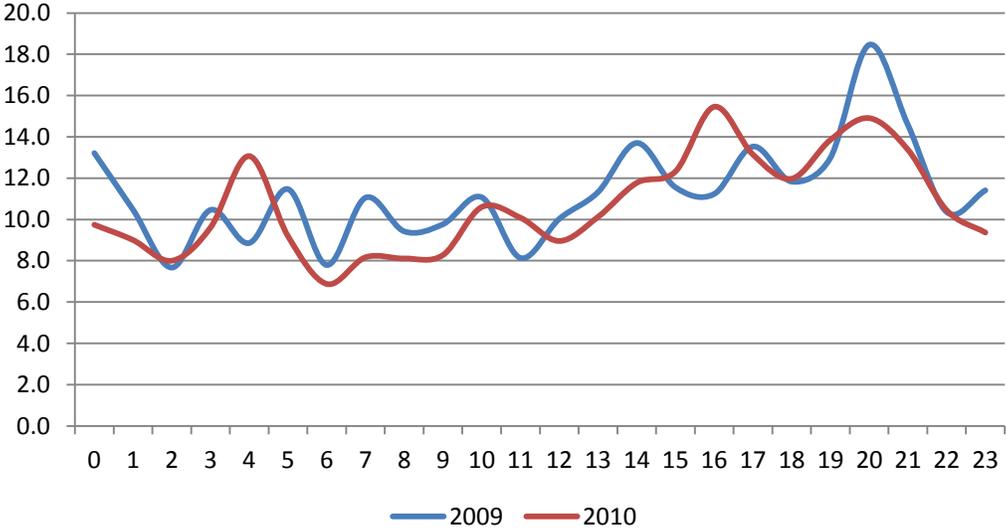
Figure 15: Structure Fire Staffing by Hour of Day

When comparing the two previous figures, although the bell curve is similar, overall staffing numbers are generally higher for structure fires than for all incidents combined.

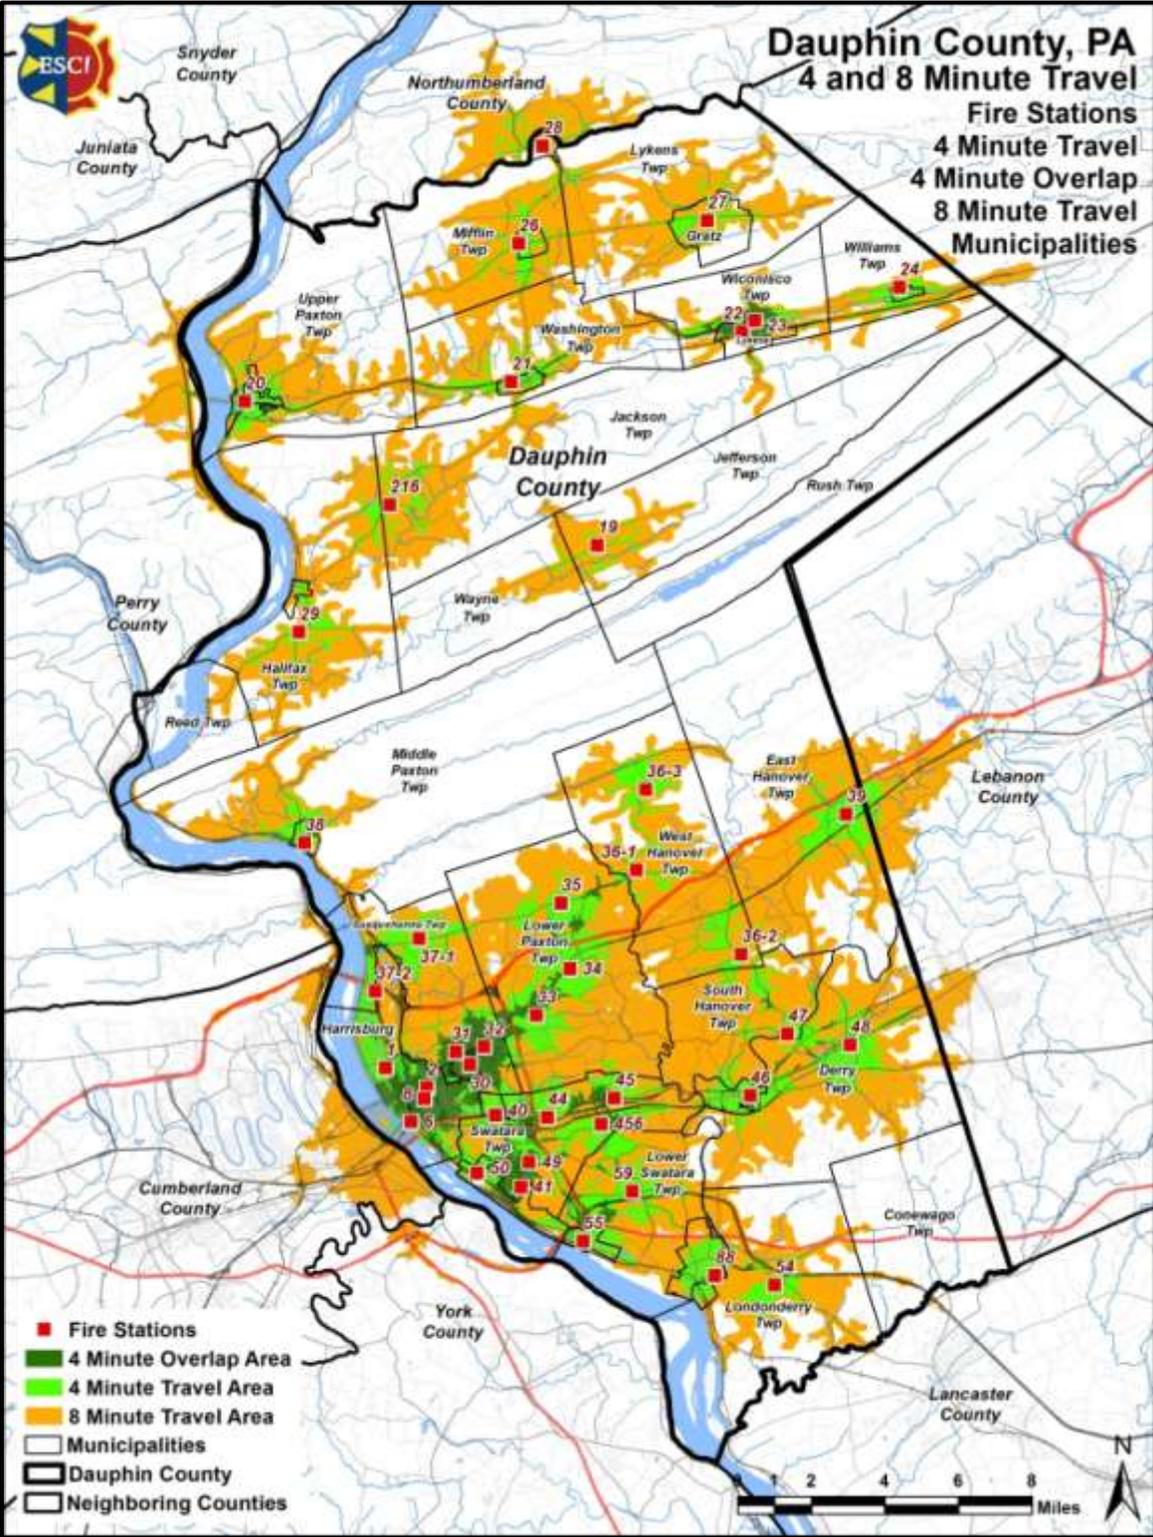
Figure 16: Station Distribution and Travel Time Models

The following map illustrates the distribution of physical resources (stations) within Dauphin County as well as several response time models based on the existing roadway network.

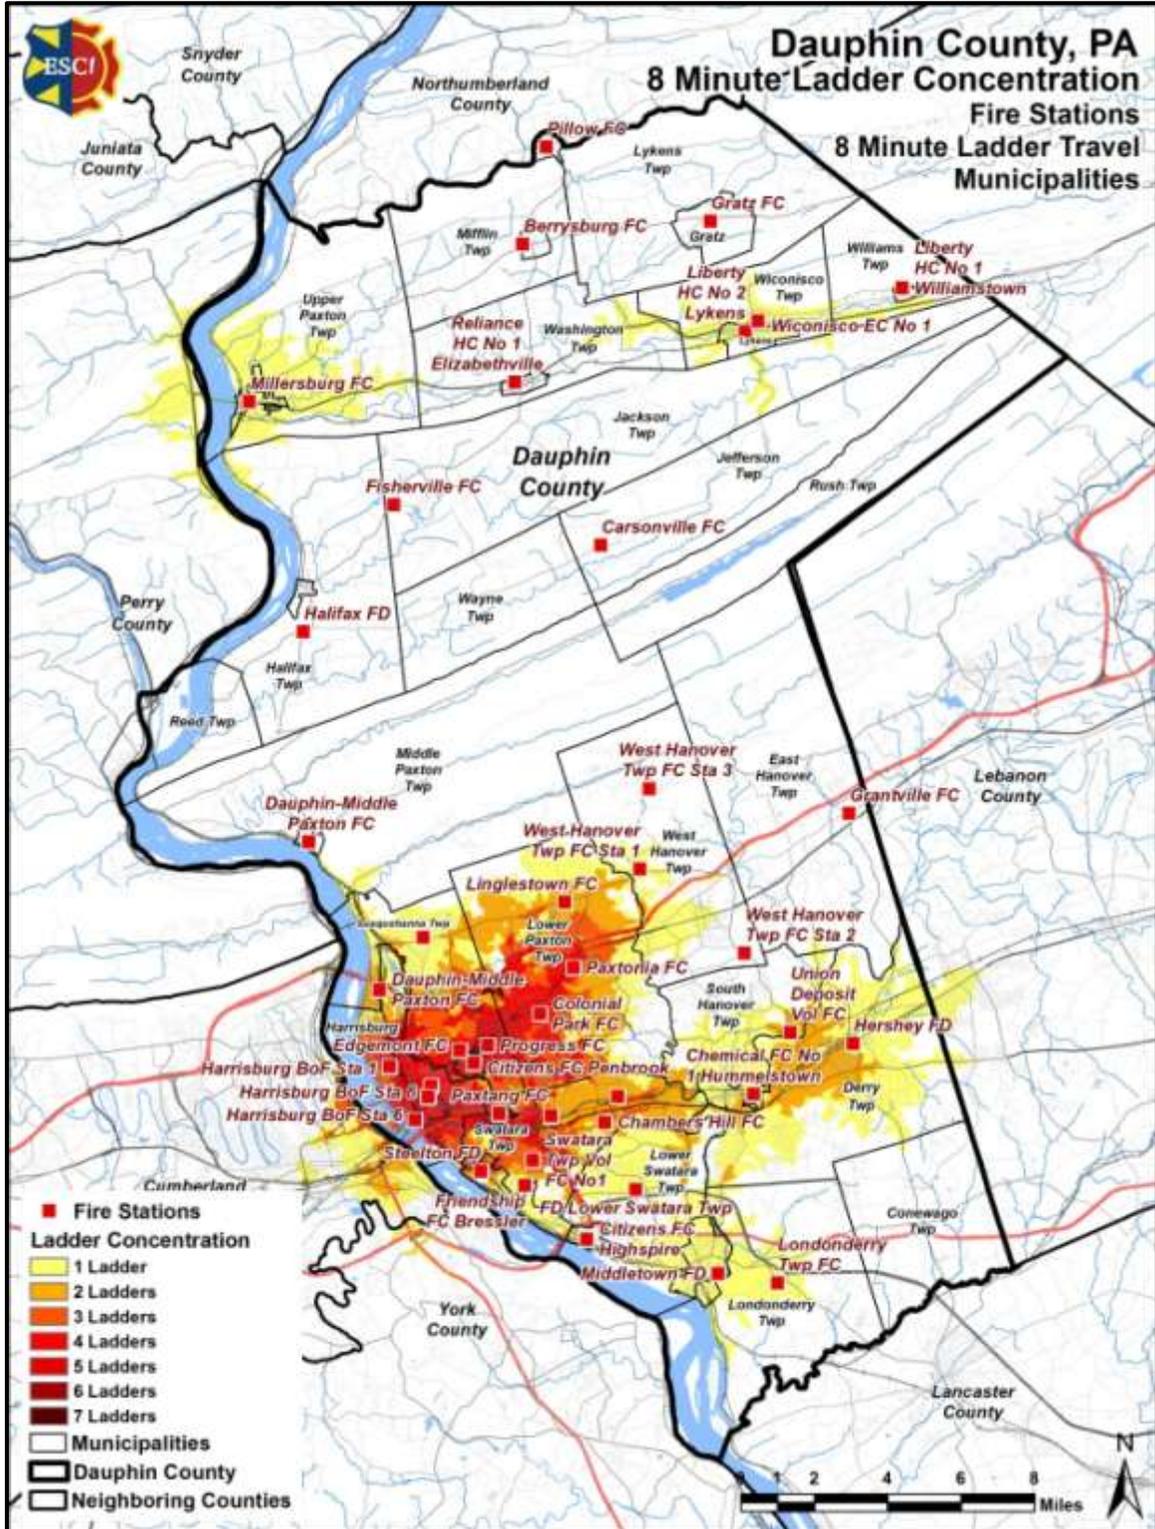
Figure 18: Ladder Concentration

concentrating more than one. The next figure illustrates the region's ability to concentrate aerial apparatus.

As with engine concentration, there are certain areas within Dauphin County where up to seven aerial apparatus (ladders) can be assembled while other areas do not have the ability to even concentrate one ladder within eight minutes. Unlike engines, however, aerial apparatus are specialized pieces of equipment and should be located in areas that contain the risks that require an elevated device. The next figure illustrates the region's rescue concentration.

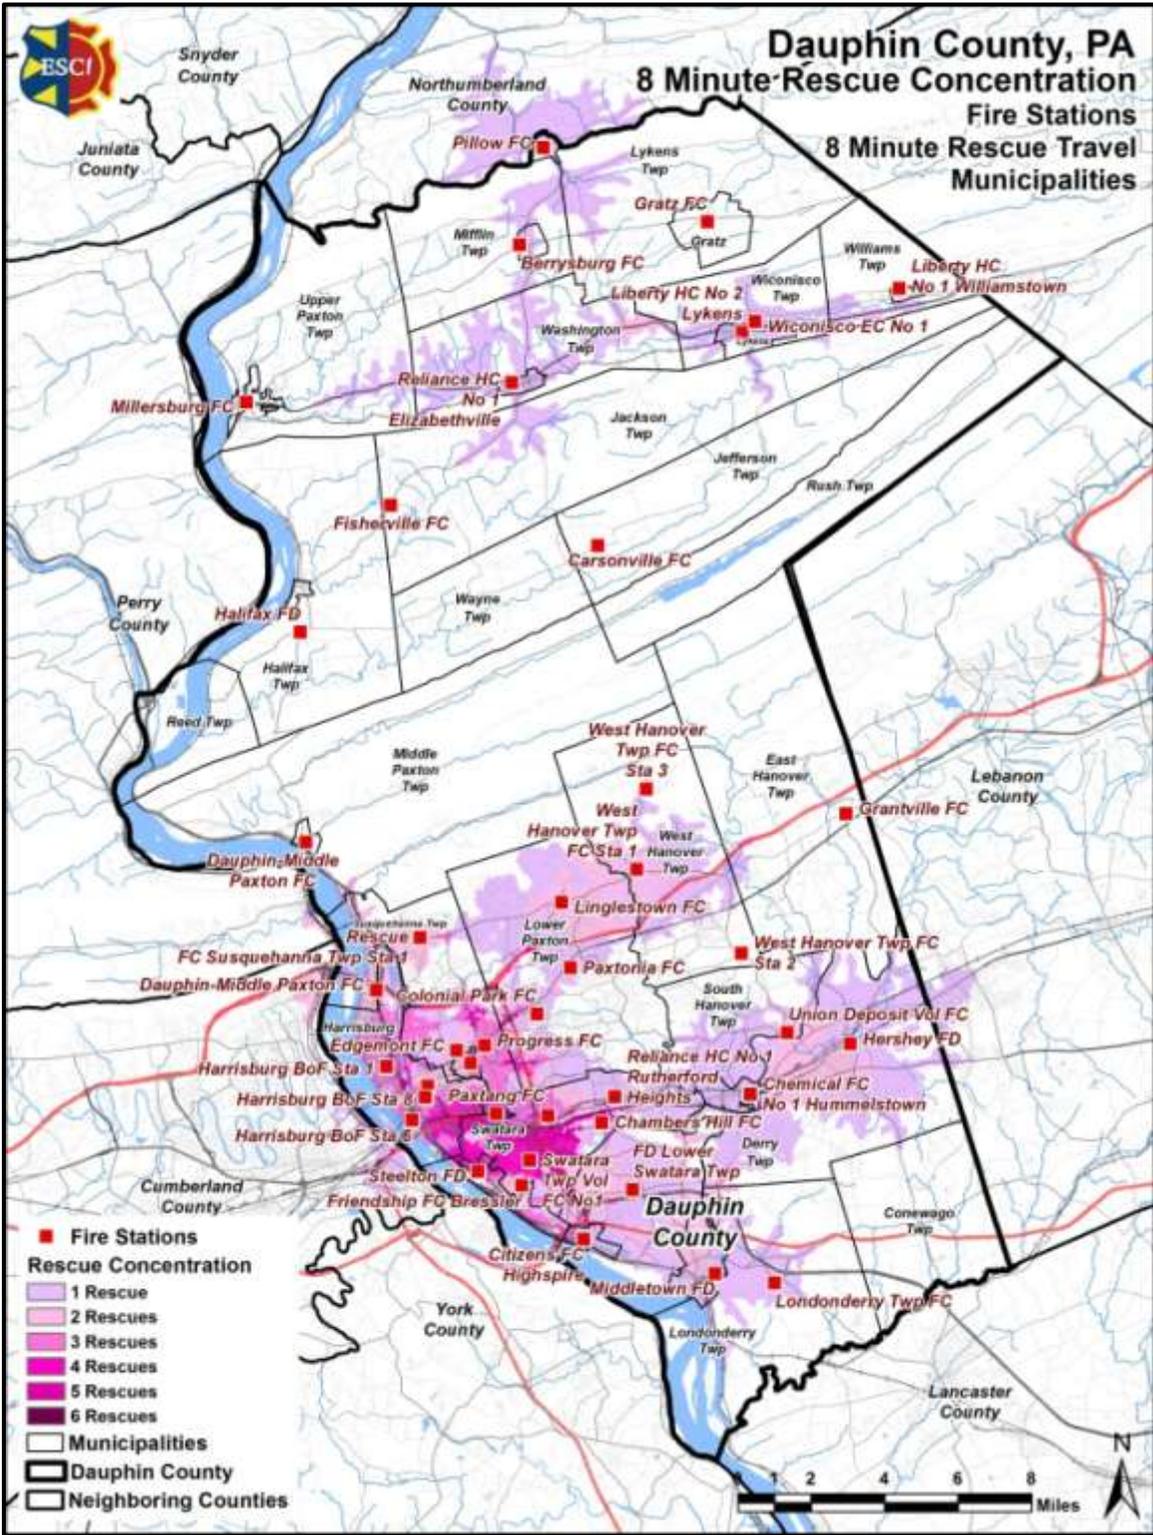
Figure 19: Rescue Concentration

Like engines and aerial apparatus, rescue concentration is heavier in some areas (up to six) while other areas do not have the capability to concentrate even one rescue vehicle within eight minutes. As with

aerial apparatus, rescue vehicles are specialized pieces of equipment and should be deployed based on risk rather than simple coverage.

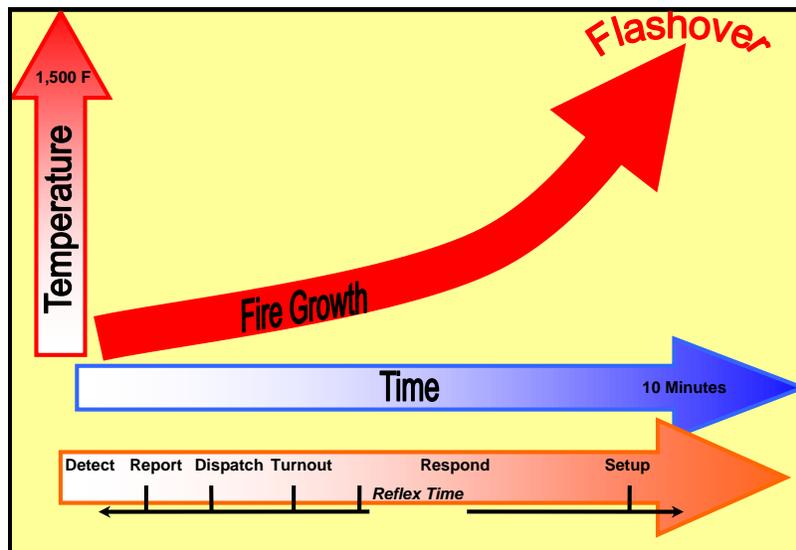
Figure 20: Time versus Temperature

In addition, the contents of buildings today have a much greater potential for heat production than in the past. The widespread use of plastics in furnishings and other building contents rapidly accelerate fire spread and increase the amount of water needed to effectively control a fire. All of these factors make the need for early application of water essential to a successful fire outcome. A number of events must take place quickly to make it possible to achieve fire suppression prior to flashover. The following figure illustrates the sequence of events.

As is apparent by this description of the sequence of events, application of water in time to prevent flashover is a serious challenge for any fire department. It is critical, though, as studies of historical fire losses can demonstrate.

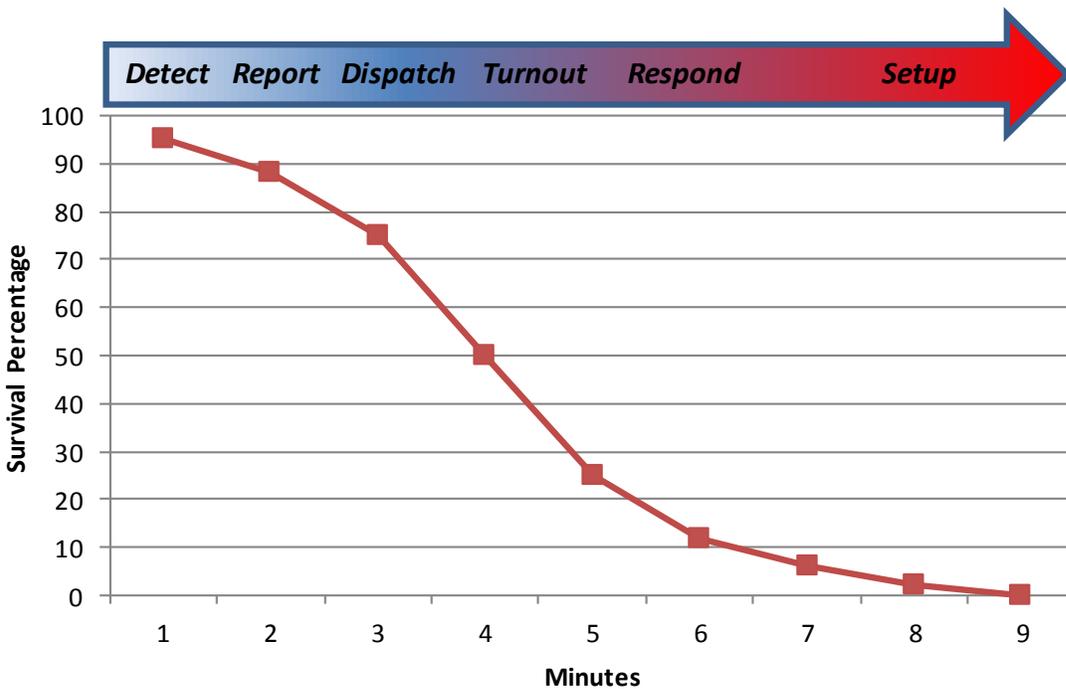
Figure 23: Cardiac Arrest Event Sequence

The following chart illustrating cardiac arrest survivability was published in a 1998 study by the Emergency medical Directors Association of California. It illustrates the value of early CPR and cardiac defibrillation.

The percentage of opportunity for recovery from cardiac arrest drops quickly as time progresses. The stages of medical response are very similar to the components described for a fire response. Recent research stresses the importance of rapid cardiac defibrillation and administration of certain medications as a means of improving the opportunity for successful resuscitation and survival.
