*Dauphin County Gaming Advisory Board
Pennsylvania*

Comprehensive Review of Fire and
Emergency Service Resources
Final

December 2011

Comprehensive Review of Fire and Emergency Service Resources

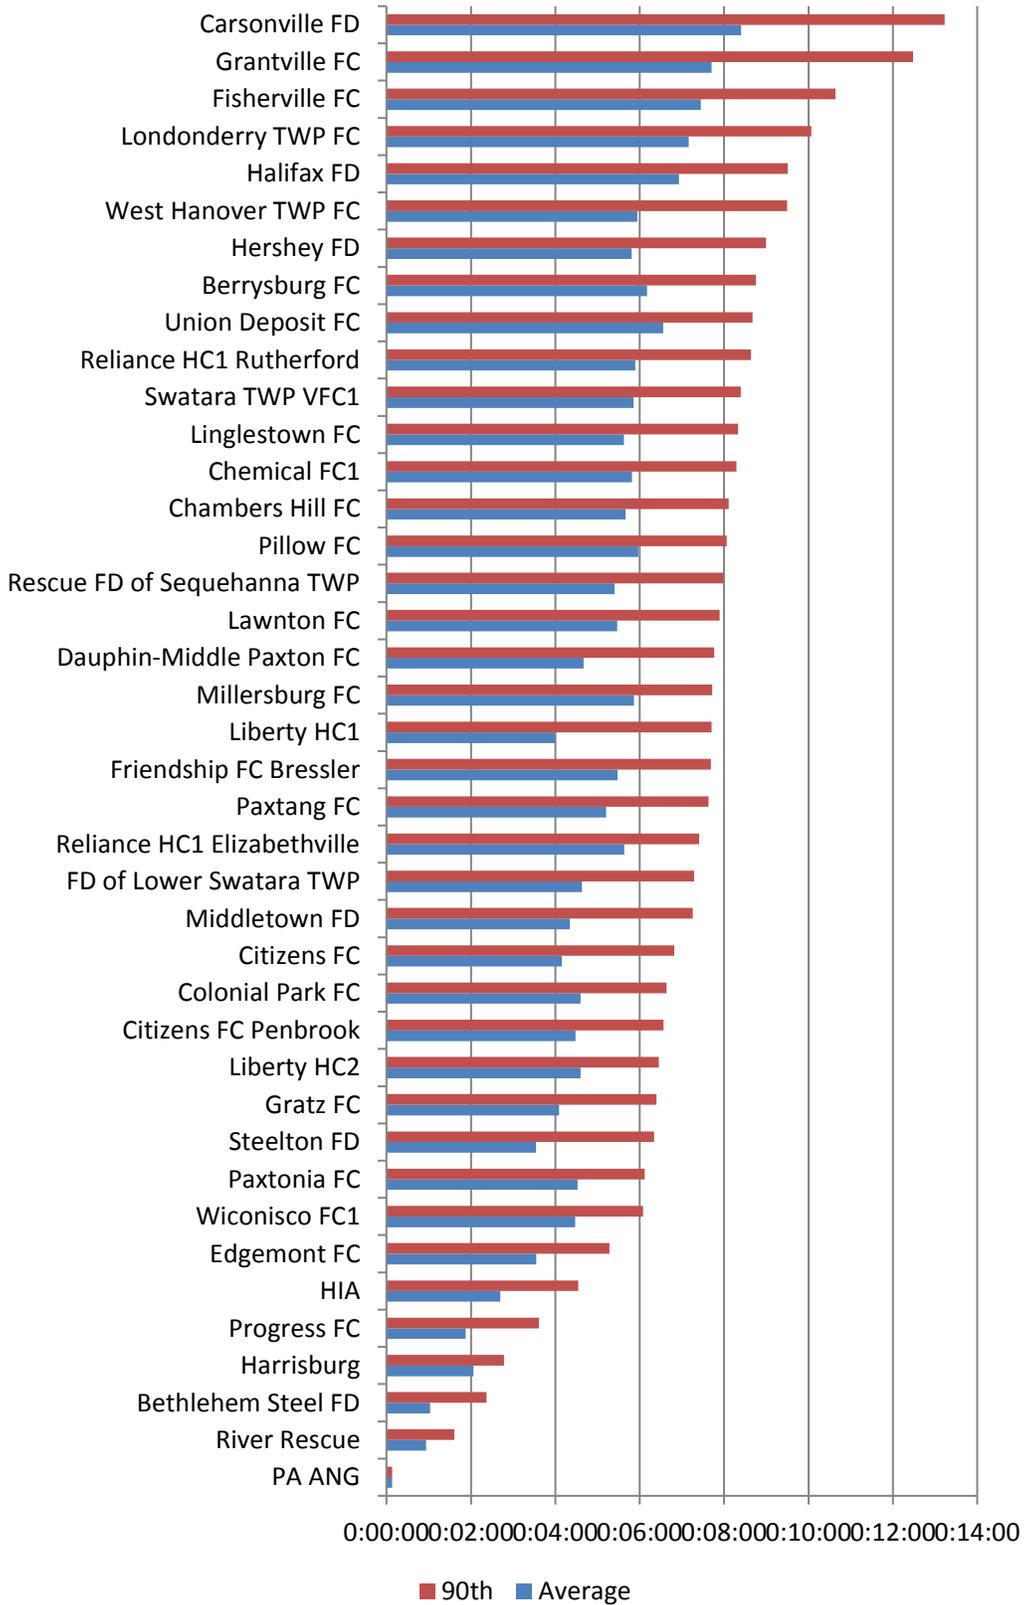
Figure 24: Average and 90th Percentile Turnout Time by Station

Generally, volunteer departments have longer turnout times than career departments due to the fact that responders do not routinely stay at volunteer stations. Career departments, however, should ensure that personnel are aware of the turnout time objectives adopted by their organization and data should be evaluated regularly to measure the department's success at meeting those objectives. The following figure illustrates the average turnout time for each station serving Dauphin County.

As illustrated in the preceding figure, turnout times between the various departments are highly variable. The following figure illustrates the average, 80th, and 90th percentile overall response time (includes turnout and travel time) for each station serving Dauphin County.

Based on the performance analysis illustrated in the previous figures, HFD (the only career department within Dauphin County) is exceeding the *NFPA 1710* recommended response objective by 59 seconds (6:59) when measured at the 90th percentile. The remaining departments' performance ranges from a low of 6:03 (Station 10) to a high of 20:13 (Fisherville Fire Company) when measured at the 80th percentile (rural standard).

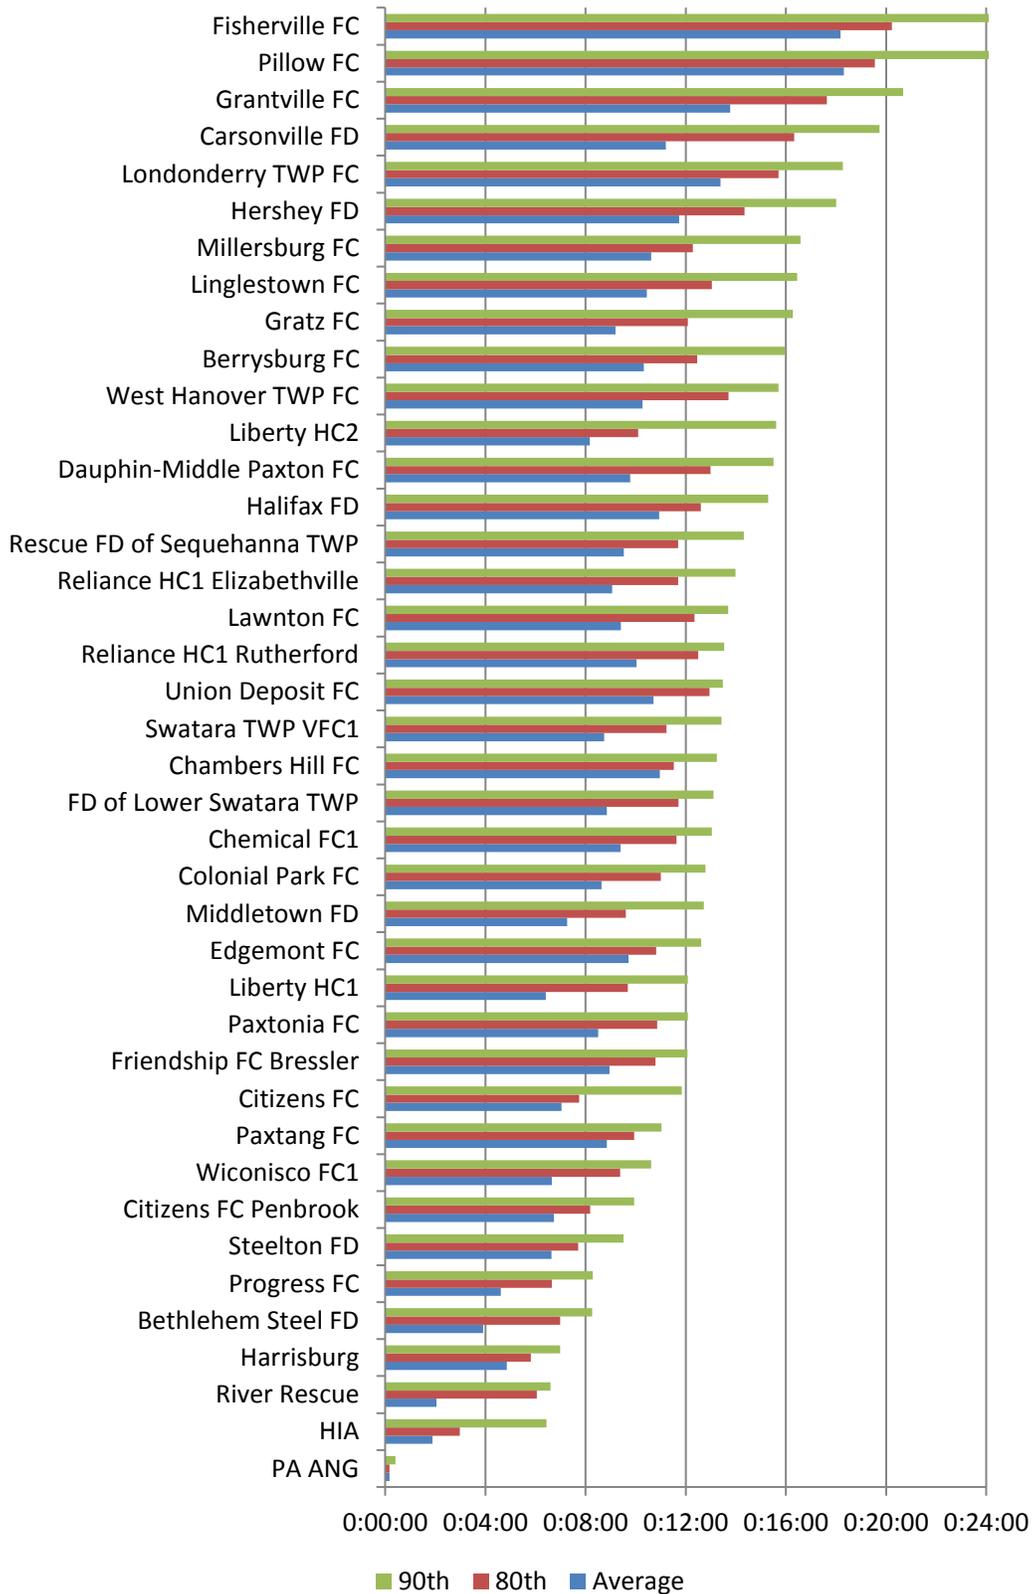
Figure 25: Average, 80th, and 90th Percentile Response Performance by Station

As discussed previously, NFPA standards differ between career and volunteer departments in regards to response performance. *NFPA 1710*, applying to career departments, recommends a five minute overall response performance when measured at the 90th percentile. *NFPA 1720*, applying to mostly volunteer departments, has variable response performance standards depending on population density: urban – 9 minutes at the 90th percentile; suburban – 10 minutes at the 80th percentile; rural – 14 minutes at the 80th percentile.

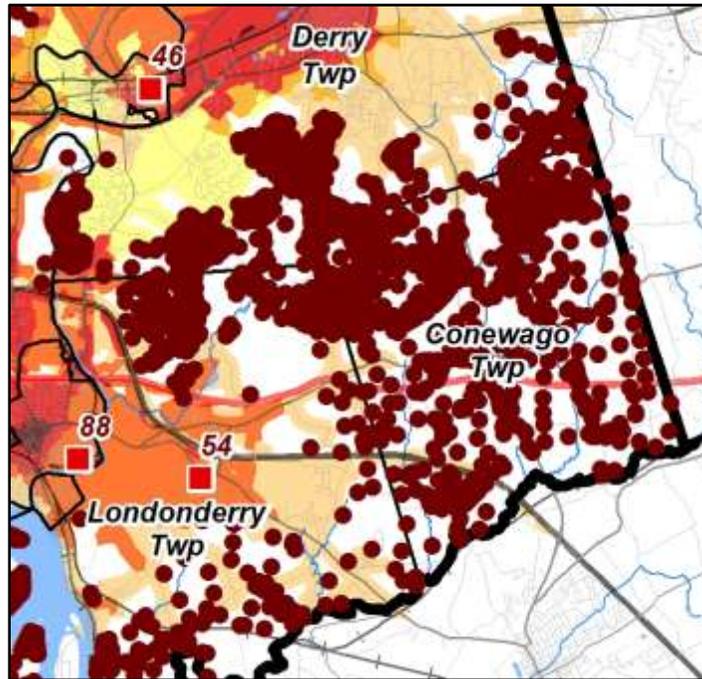
Figure 28: Conewago Township Protection Deficiency Zone

One of these is the entire Conewago Township area, as shown in Figure 37. In the figure, each dot represents a residential parcel that is greater than eight minutes travel time from a fire station. This rural area of southeastern Dauphin County is well over eight minutes in travel time from any fire engine, even those located in the next county. An ideal fire station location would be near the intersection of Route 743 and Route 341, in the small community of Deodate. However, it is unclear whether a sufficient number of volunteers could be recruited in this immediate area to keep the station viable. For purposes of grant funding consideration, however, any future effort to establish fire protection in or near this area should be supported if sufficient manpower capability can be demonstrated.

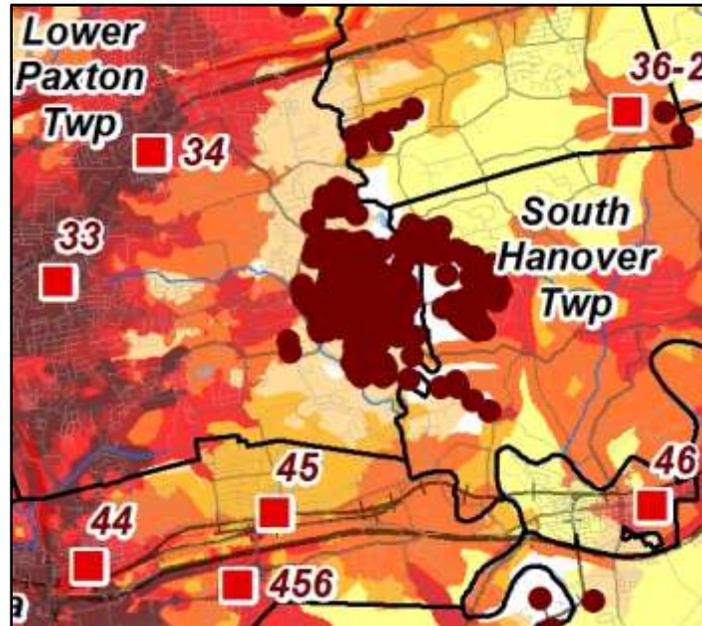
Figure 29: Lower Paxton/South Hanover Protection Deficiency Zone

A second area of deficiency is located along the border area between South Hanover Township and Lower Paxton Township, as shown in Figure 38. An ideal fire station location would be along Union Deposit Road, somewhere between Myes Road and Hoernerstown. Currently, it does not appear that a sufficient cluster of population exists in this area to support a station and service demand is still relatively low. However, several residential subdivisions have been built in the vicinity and it is possible that additional subdivisions will be built, increasing both population and demand. Again, any future effort to establish fire protection in or near this area should be supported if sufficient manpower capability can be demonstrated.

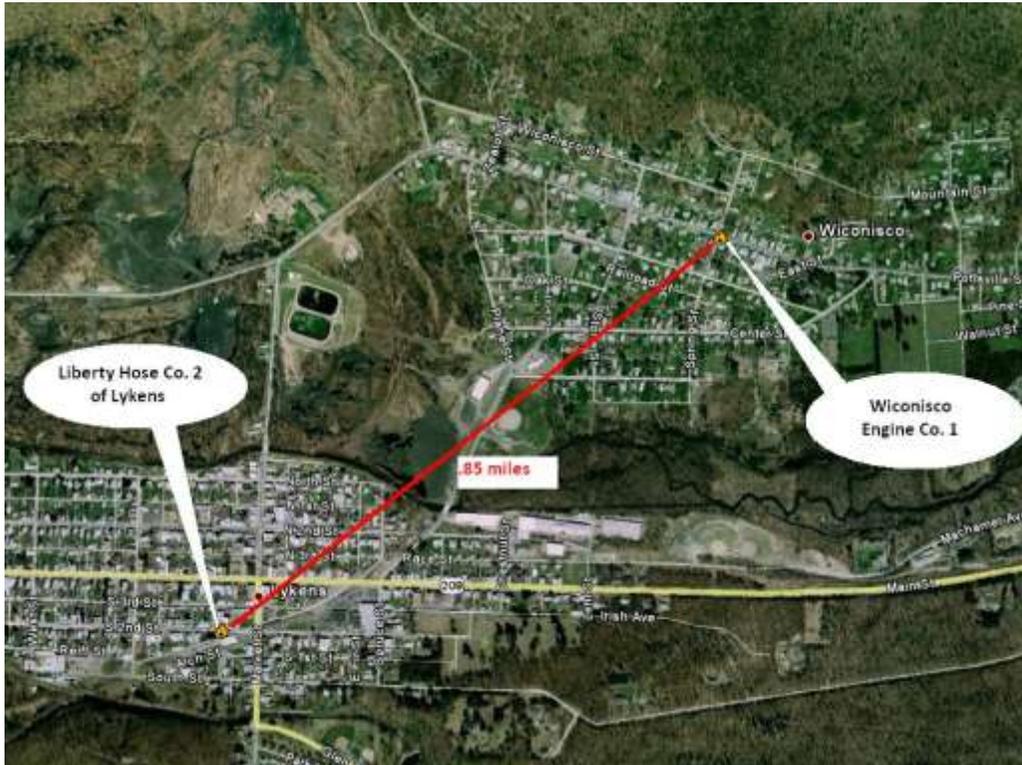
As seen in the following figure, the Wiconisco Engine Company 1 and the Liberty Hose Company 2 of Lykens are located only 0.85 miles from each other. As a result, their response time footprints are very similar at both the four and eight-minute level. This represents an opportunity for improving efficiency if the fire companies could be unified into a single facility.

Figure 30: Lykens-Wiconisco Redundancy Area

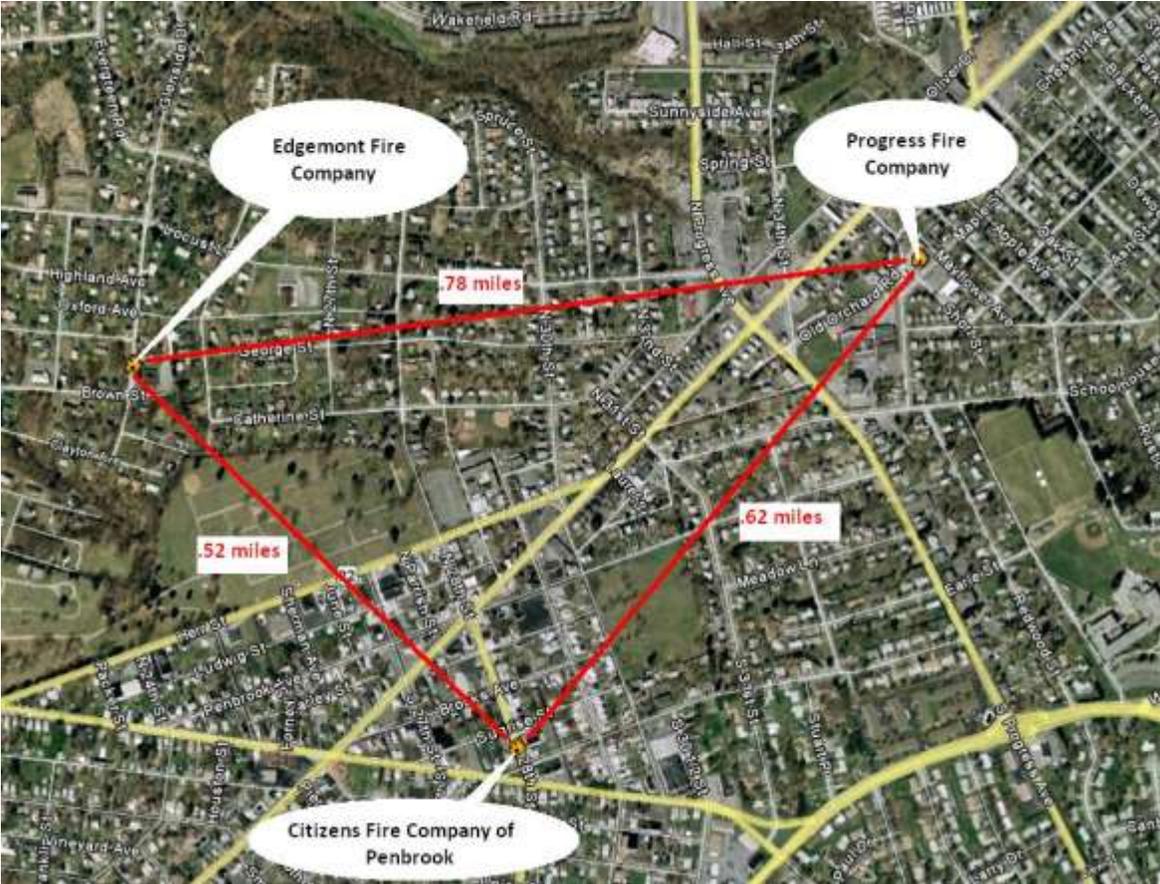
As seen in the next figure, the Edgemont Fire Company, Progress Fire Company, and Citizens Fire Company of Penbrook are located in proximity of less than one mile from each other. As a result, their response time footprints have a high degree of overlap at both the four and eight-minute level. Again, this represents an opportunity for improving efficiency if two or more of these fire companies could be unified into a single facility.

Figure 31: Edgemont-Progress-Penbrook Redundancy Area

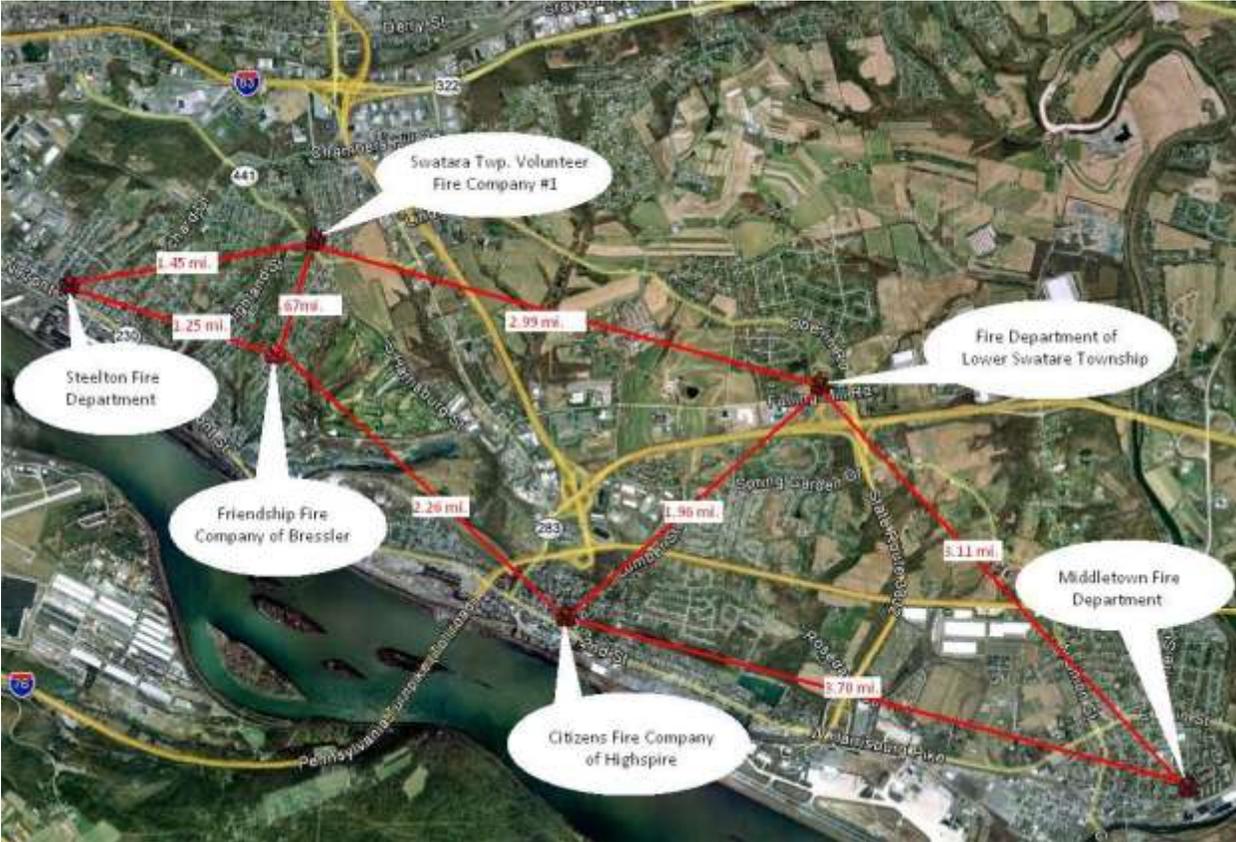
As seen in the next figure, the Steelton Fire Department, Swatara Township Fire Company #1, Friendship Fire Company of Bressler, Citizen's Fire Company of Highspire, Fire Department of Lower Swatara Township, and Middletown Fire Department are all located within a 21 square mile area. The distances between each station are shown in the figure. While the proximity of the Middletown station in the eastern portion of this cluster is greater than three miles and probably justified, the distance between the Fire Department of Lower Swatara Township and Citizen's Fire Company of Highspire is less than two miles, a distance that is not indicative of well-planned resource distribution. The redundancy is even more significant in the western area of this cluster, with Steelton Fire Department, Swatara Township Volunteer Fire Company #1 and Friendship Fire Company of Bressler all being located in an area of less than one square mile. Again, as a result of station positioning, the response time footprints of several of the stations in this cluster area have a high degree of overlap at both the four and eight-minute level. As with the other examples, this represents an opportunity for improving efficiency if two or more of these fire companies could be unified into a single facility.

Figure 32: Steelton to Middletown Redundancy Areas

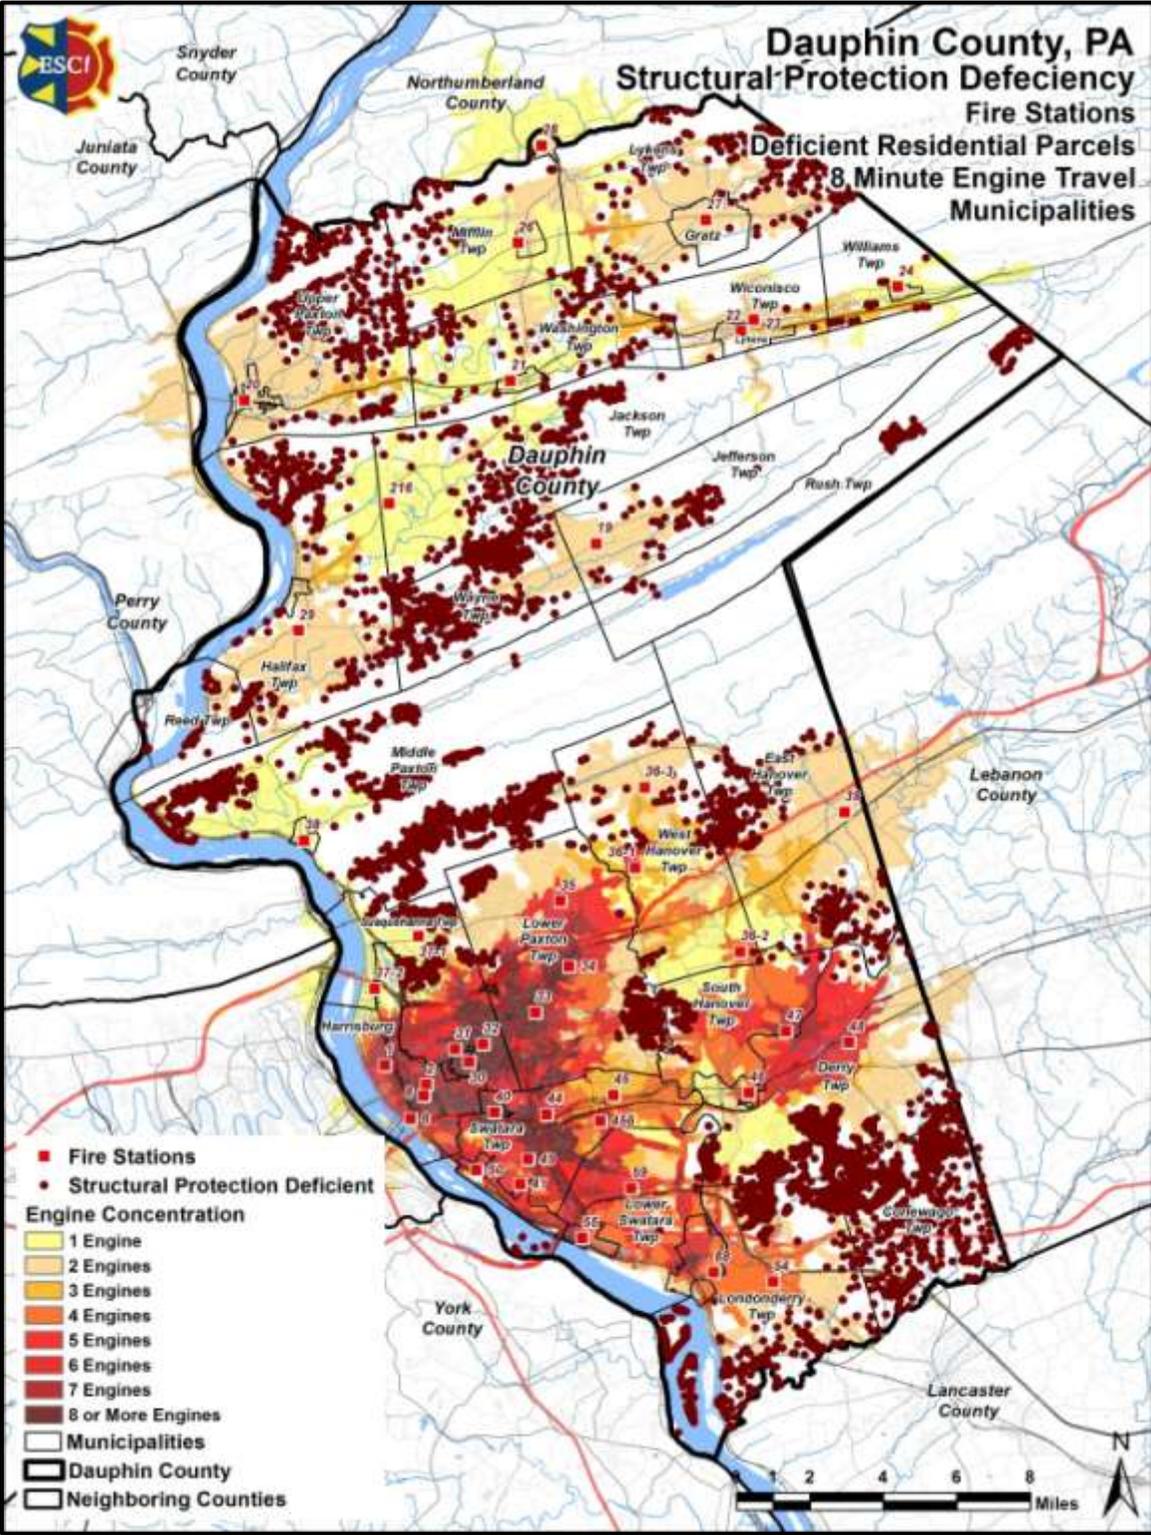
In developing future system needs in regards to apparatus for the fire agencies serving Dauphin County, ESCI began with examining areas of potential apparatus deficiency as well as redundancy. This examination began with potential engine deficiency/redundancy. Engine deficiency models were constructed using the engine concentration models produced previously combined with a parcel by parcel analysis of areas that could not produce a minimum number of apparatus within eight minutes. The following figure illustrates those areas of deficiency.

Figure 34: Engine Deficiency

As illustrated in the figure above, those areas immediately around Harrisburg and extending east have the ability to assemble high numbers of engines while areas to the extreme southeast, as well as other

areas scattered throughout the county, are unable to produce sufficient apparatus for a structural fire flow and back-up pump capability within eight minutes travel time. With this in mind, ESCI evaluated existing resources and produced a potential schedule of redundancy/deficiency that could be used as a guide to future apparatus (engine) replacement. The apparatus below are considered by ESCI to be located in areas of redundancy. Grant funding of replacements for these apparatus should be avoided or considered lowest priority.

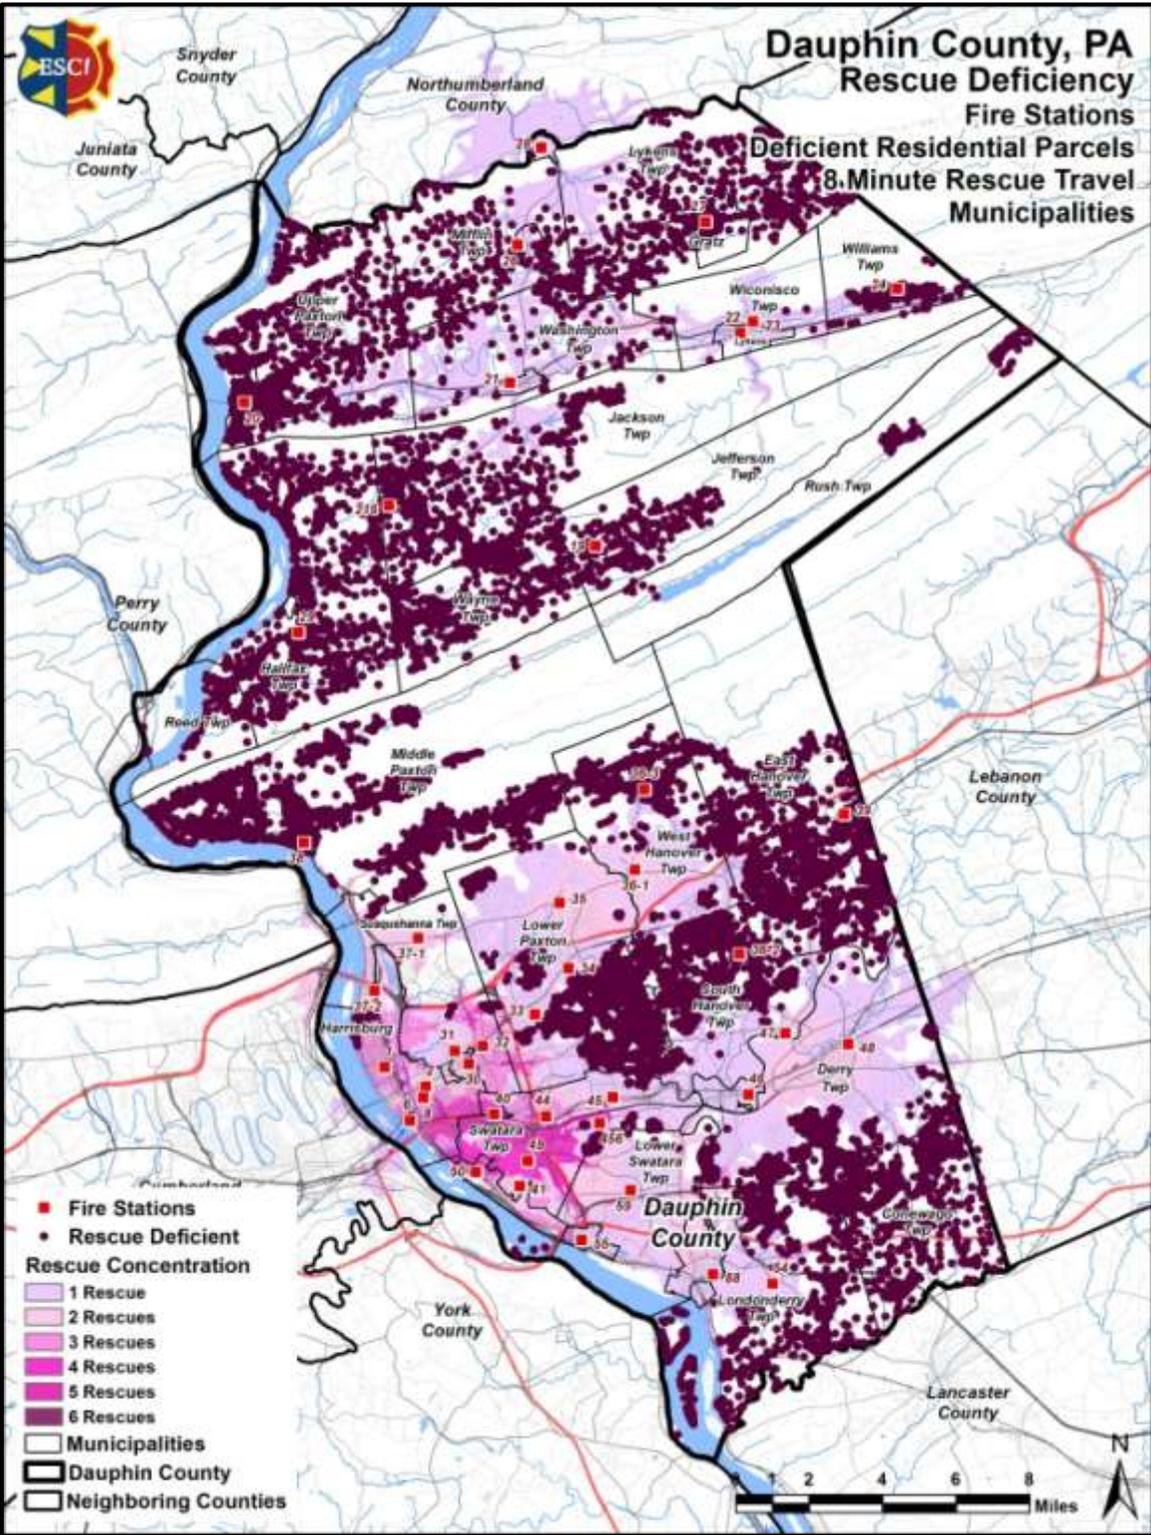
The analysis of areas of redundancy and/or deficiency continues with an evaluation of rescue deployment. Areas of deficiency are illustrated in the following figure.

Figure 37: Rescue Deficiency

As illustrated previously with engine deployment, there are areas within Dauphin County that are over-resourced with rescue apparatus as well as areas that are deficient. The highest concentration of rescue

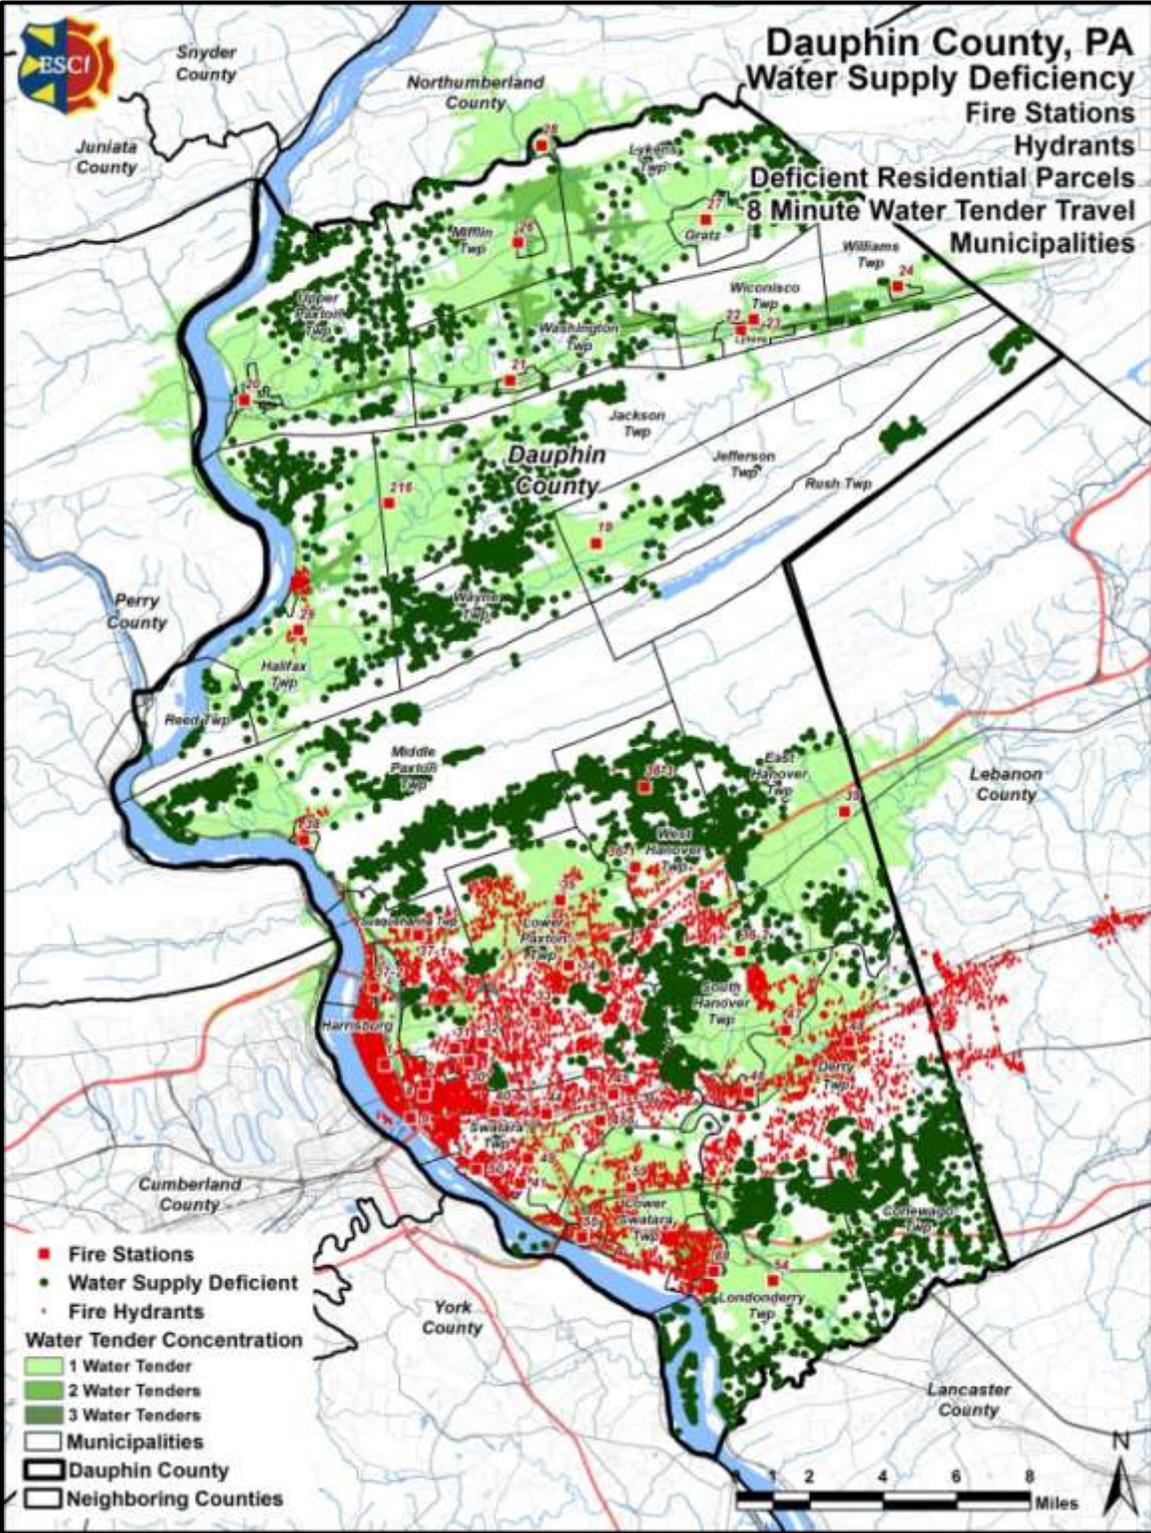
The analysis of areas of redundancy and/or deficiency continues with an evaluation of tanker/tender deployment. Areas of deficiency are illustrated in the following figure.

Figure 40: Tanker/Tender Deficiency

As illustrated on the preceding figure, there are large areas in and around Harrisburg that are currently supplied by hydrants. This area also extends to the east along the turnpike to and into Lebanon County.

Since these areas are serviced by hydrants, tanker/tender deployment is less necessary. Based on the apparatus inventory presented previously, Dauphin County currently maintains 17 tanker/tender apparatus, mostly scattered throughout the unhydranted areas. Based on the deployment of apparatus and the water supply deficiency presented in the preceding figure, ESCI does not find any areas of redundancy in tanker/tender apparatus. However, there are two areas that ESCI deems deficient in water supply services as indicated in the following figure. Grant funding should be considered for these additional apparatus, when and if facilities and staffing will accommodate.

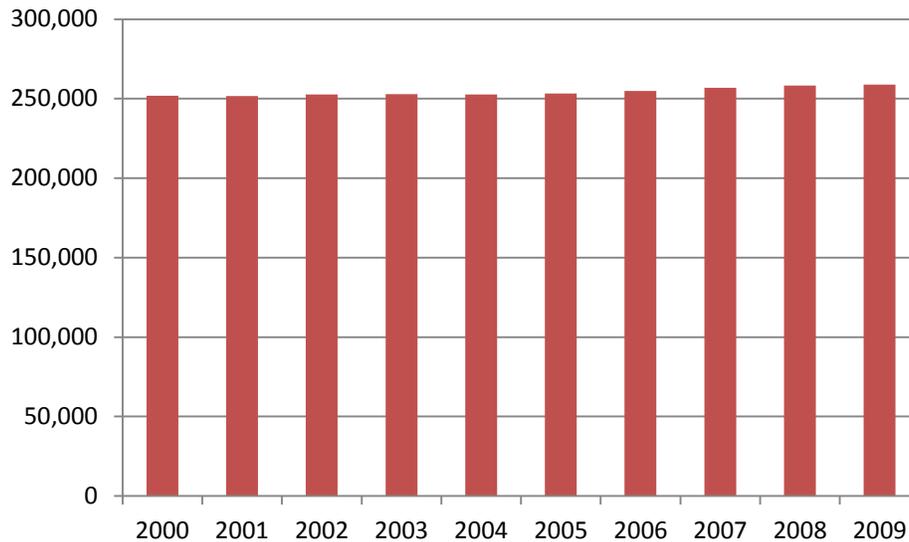
The fire departments serving Dauphin County provide primary fire and emergency medical first response services to all of Dauphin County. The population of the entire service area of the agencies was estimated at 268,188 in the 2010 U.S. Census.⁶ This population figure represents a 6.5 percent increase over the 2000 census, when the population of was estimated at 251,832. The following chart provides some historical information on population for Dauphin County.

Figure 47: Population Growth History

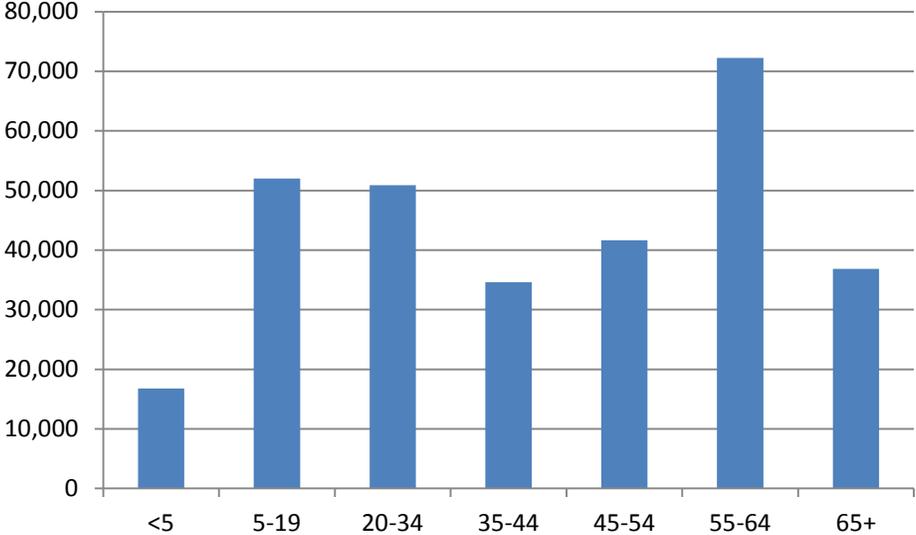
Figure 48: Population by Age

As can be seen from the figure above, 13.7 percent of the population is 65 years of age or older and 6.3 percent of the population is under 5 years of age, placing a total of 20.0 percent of the county’s population within the significant target age groups that pose the highest risk in residential fire incidents. The following figure illustrates general housing characteristics for Dauphin County.

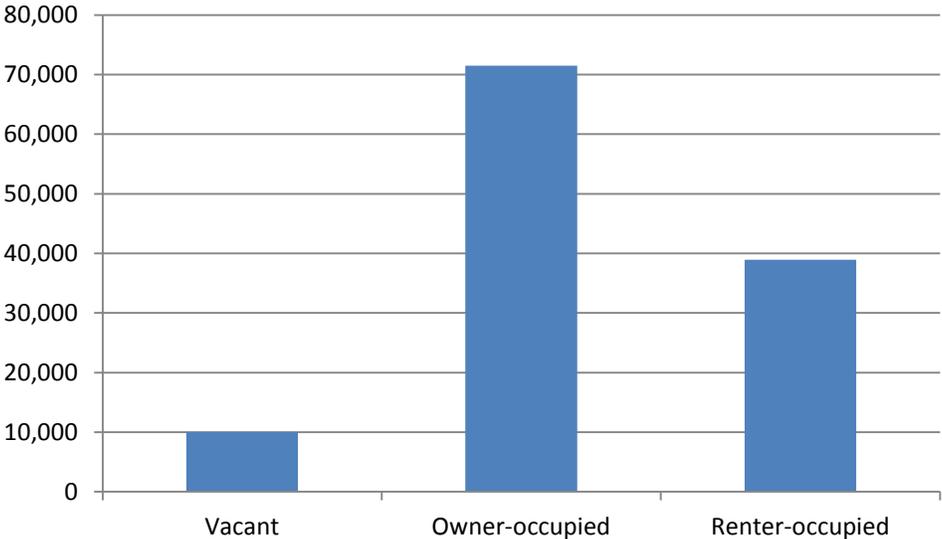
Figure 49: Housing by Occupancy

In general, high rates of vacancy and/or rental properties tend to indicate socioeconomic conditions that generate moderate to higher call volumes. Dauphin County has a relatively high percentage of rental properties and a modest rate of vacant properties. This indicates that, generally, the conditions within Dauphin County are likely to generate a slightly higher overall emergency services workload when compared to other communities of similar population.

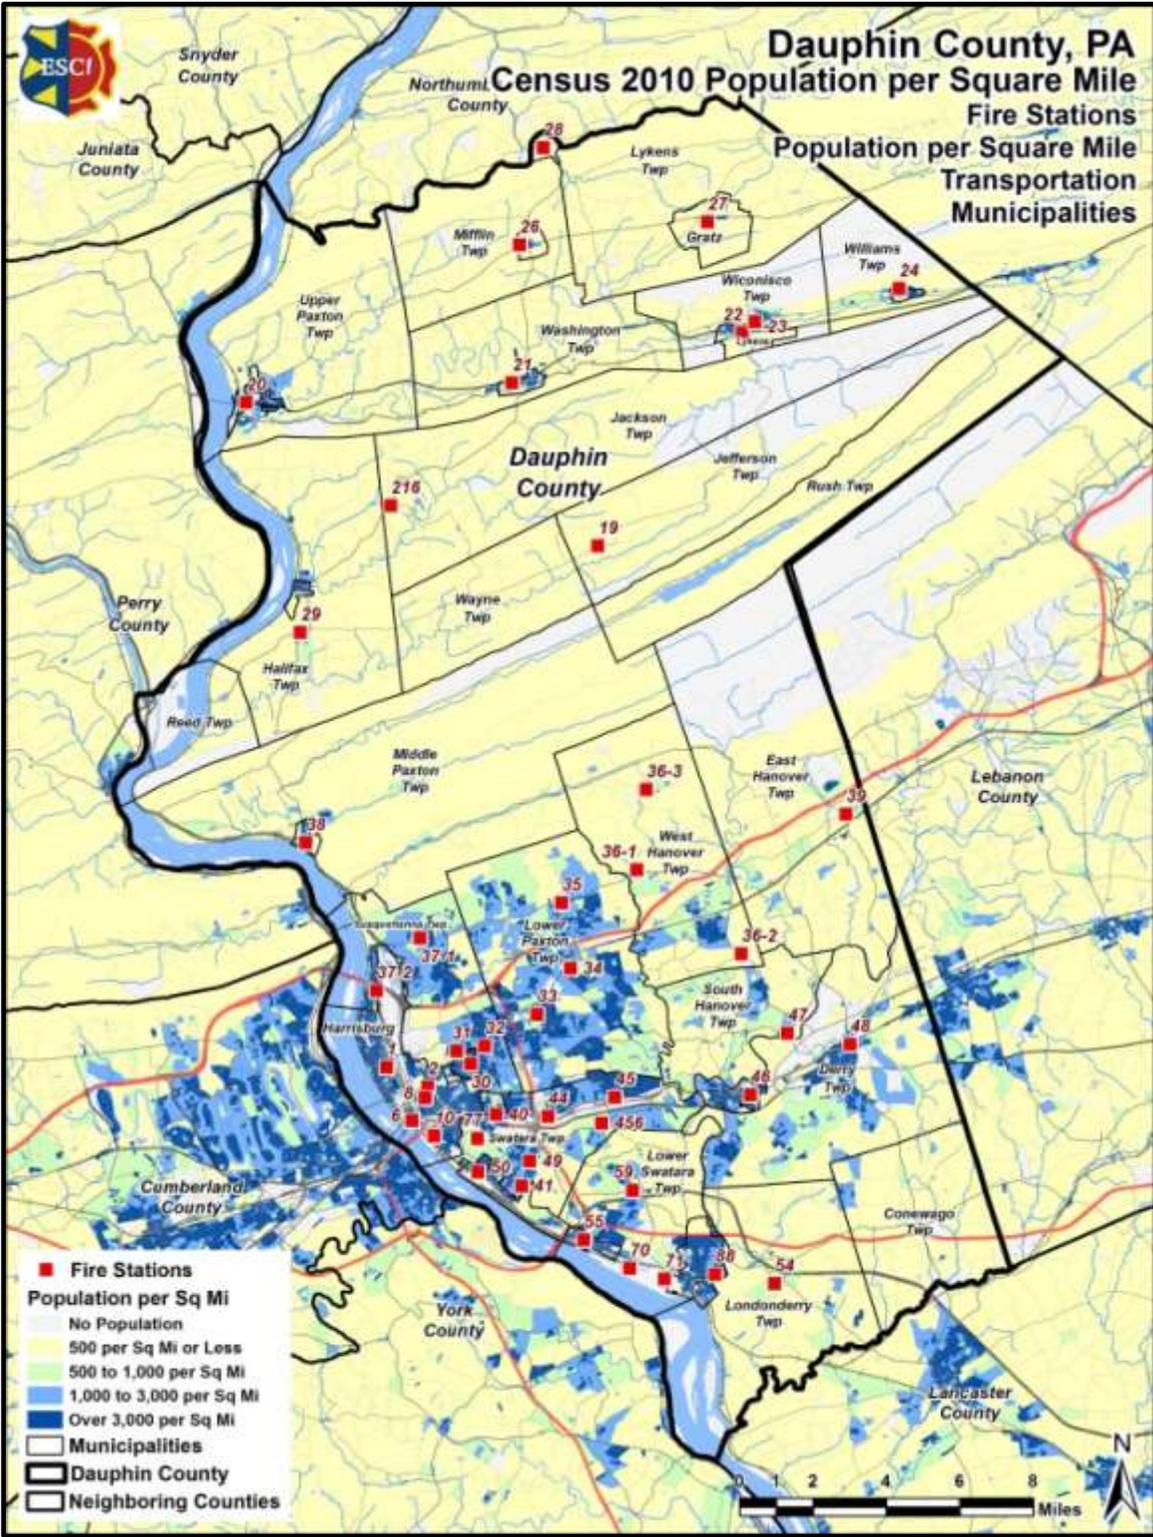
It is also useful to assess the distribution of the population within Dauphin County, since there is a direct correlation between population density and service demand. The following map displays the population density of the county, based on information from the 2000 U.S. Census.

Figure 50: Dauphin County Population Density

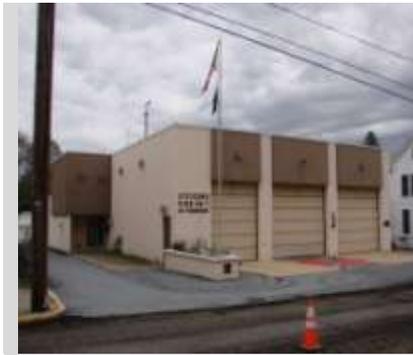
Citizens Fire Company of Penbrook

Is this facility solely used for administrative offices	No
Facility used for:	Active response station, Administrative offices (HQ station), Training or drill facility, Maintenance facility, Support/Logistics facility
Address of Facility	134 S. 28th St. Harrisburg, PA 17103-1997
Facility Ownership	501(c3) Corporation Owned
Is there an outstanding mortgage on this structure?	None
Year Facility Initially Constructed	1972
Number of Major Additions or Renovations	1
Year of Major Addition/Renovation	2008

Building Square Feet	6,400
Apparatus Bays:	
<i>Back-in, single unit</i>	0
<i>Back-in, used with stacked parking</i>	0
<i>Drive-through use, single unit</i>	0
<i>Drive-through capable, used with stacked parking</i>	2
Building Height	One-story
Construction Type	TYPE III-A--Protected Combustible (one-hour rating)
Outside Finish	Masonry block
Unusual Construction Features	None
Overall Construction Condition	Worn paint or finishes, Structural problems evident or reported
Roof Type	Flat- membrane
Roof Age	Original to building
Roof Condition	Significant leaking evident or reported
Type of Heating System (all that apply)	Radiant- natural gas
Heating System Age	Original to building
Air Conditioning (all that apply)	Central air- entire building
Any Other Known Maintenance or Disrepair Issues	Yes Flooded basement, Leaky roof, Falling ceiling tiles throughout, Cleanliness challenges

Apparatus Exhaust Removal	Direct connect vacuum system, connected
Underground Storage Tanks Present	No
Type of Underground Storage Tank	
Age of Underground Storage Tank	
Type of Leak Detection in Place

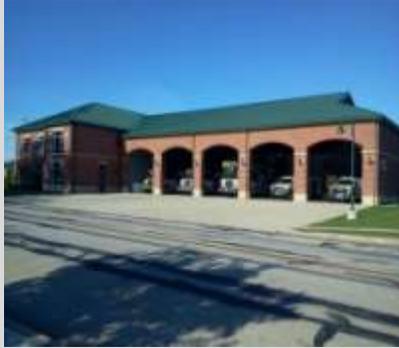
Colonial Park Fire Company

Is this facility solely used for administrative offices No
 Facility used for: Active response station, Administrative offices (HQ station), Training or drill facility, Support/Logistics facility
 Address of Facility 433 South Houcks Rd.
 Facility Ownership 501(c3) Corporation Owned, Municipal Owned
 Is there an outstanding mortgage on this structure? Yes- \$ 600,000.00
 Year Facility Initially Constructed 2005
 Number of Major Additions or Renovations 0

Building Square Feet 12,000
 Apparatus Bays:
 Back-in, single unit 4
 Back-in, used with stacked parking 0
 Drive-through use, single unit 1
 Drive-through capable, used with stacked parking 0
 Building Height Two-story
 Construction Type TYPE II-A--Protected Non-Combustible
 Outside Finish Brick veneer, Masonry block
 Unusual Construction Features None
 Overall Construction Condition Good condition
 Roof Type Peaked- metal
 Roof Age Original to building
 Roof Condition No known problems
 Type of Heating System (all that apply) Forced air- natural gas
 Heating System Age Original to building
 Air Conditioning (all that apply) Central air- entire building
 Any Other Known Maintenance or Disrepair Issues Yes, Poor heating in engine bay

Apparatus Exhaust Removal	Forced air through structure, auto activation
Underground Storage Tanks Present	No
Type of Underground Storage Tank	
Age of Underground Storage Tank	
Type of Leak Detection in Place

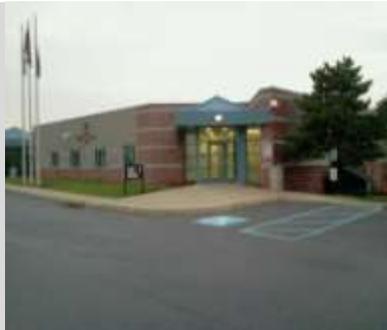
Dauphin County Hazardous Materials Team

Is this facility solely used for administrative offices	Yes
Address of Facility	911 Gibson Blvd.
Facility Ownership	Municipal Owned
Is there an outstanding mortgage on this structure?	None
Year Facility Initially Constructed	1995
Number of Major Additions or Renovations	0

Construction Type	TYPE II-A--Protected Non-Combustible
Outside Finish	Brick veneer, Masonry block
Unusual Construction Features	None
Overall Construction Condition	Good condition
Roof Type	Flat- membrane
Roof Age	Original to building
Roof Condition	No known problems
Type of Heating System (all that apply)	Forced air- natural gas
Heating System Age	Original to building
Air Conditioning (all that apply)	Central air- entire building
Any Other Known Maintenance or Disrepair Issues	Yes, Foundation leaking

Apparatus Exhaust Removal	
Underground Storage Tanks Present	No
Type of Underground Storage Tank	
Age of Underground Storage Tank	
Type of Leak Detection in Place

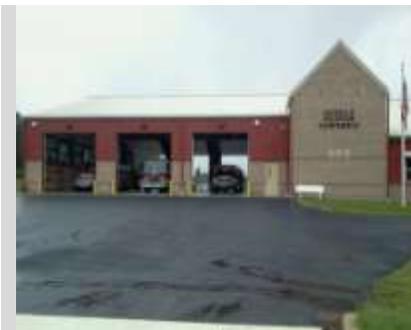
Dauphin-Middle Paxton Fire Company

Is this facility solely used for administrative offices	No
Facility used for:	Active response station
Address of Facility	10 Elizabeth Ave.
Facility Ownership	501(c3) Corporation Owned
Is there an outstanding mortgage on this structure?	Mortgage Status Uncertain
Year Facility Initially Constructed	2011
Number of Major Additions or Renovations	0

Back-in, single unit 0
Back-in, used with stacked parking 0
Drive-through use, single unit 0
Drive-through capable, used with stacked parking 3
 Building Height One-story
 Construction Type TYPE I-A--Fire Resistive Non-combustible
 Outside Finish Brick veneer, Metal siding, Masonry block
 Unusual Construction Features None
 Overall Construction Condition Good condition
 Roof Type Peaked- metal
 Roof Age Original to building
 Roof Condition No known problems
 Type of Heating System (all that apply) Forced air- natural gas
 Heating System Age Original to building
 Air Conditioning (all that apply) Central air- living and administrative areas only
 Any Other Known Maintenance or Disrepair Issues Yes, Sprinkler system leaking at the joints

Apparatus Exhaust Removal Forced air through structure, auto activation
 Underground Storage Tanks Present No
 Type of Underground Storage Tank
 Age of Underground Storage Tank
 Type of Leak Detection in Place

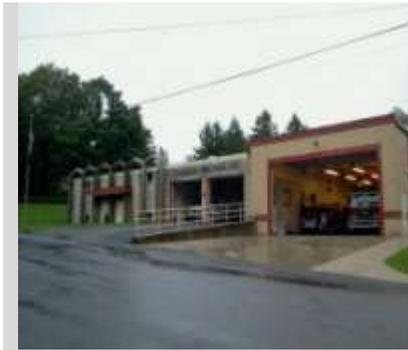
Edgemont Fire Company

Is this facility solely used for administrative offices	No
Facility used for:	Active response station
Address of Facility	1407 North 25th.
Facility Ownership	501(c3) Corporation Owned
Is there an outstanding mortgage on this structure?	Mortgage Status Uncertain
Year Facility Initially Constructed	1968
Number of Major Additions or Renovations	1
Year of Major Addition/Renovation	2002

Building Square Feet	8,000
Apparatus Bays:	
<i>Back-in, single unit</i>	2
<i>Back-in, used with stacked parking</i>	1
<i>Drive-through use, single unit</i>	0
<i>Drive-through capable, used with stacked parking</i>	0
Building Height	One-story
Construction Type	TYPE II-A--Protected Non-Combustible
Outside Finish	Masonry block
Unusual Construction Features	None
Overall Construction Condition	Good condition
Roof Type	Flat- membrane
Roof Age	1 to 10 years
Roof Condition	No known problems
Type of Heating System (all that apply)	Forced air- natural gas
Heating System Age	1 to 10 years
Air Conditioning (all that apply)	Central air- living and administrative areas only
Any Other Known Maintenance or Disrepair Issues	None

Apparatus Exhaust Removal Forced air through structure, auto activation
 Underground Storage Tanks Present No
 Type of Underground Storage Tank
 Age of Underground Storage Tank
 Type of Leak Detection in Place

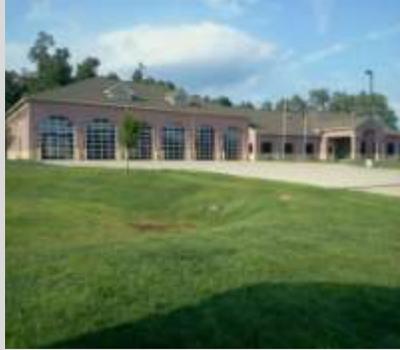
Fire Department of Lower Swatara Township

Is this facility solely used for administrative offices	No
Facility used for:	Active response station, Administrative offices (HQ station), Support/Logistics facility
Address of Facility	1350 Fulling Mill Rd.
Facility Ownership	Municipal Owned
Is there an outstanding mortgage on this structure?	Yes- Amount? \$2,025,000.00
Year Facility Initially Constructed	2008
Number of Major Additions or Renovations	0

Building Square Feet	28,000
Apparatus Bays:	
<i>Back-in, single unit</i>	2
<i>Back-in, used with stacked parking</i>	0
<i>Drive-through use, single unit</i>	4
<i>Drive-through capable, used with stacked parking</i>	0
Building Height	One-story
Construction Type	TYPE II-A--Protected Non-Combustible
Outside Finish	Masonry block
Unusual Construction Features	None
Overall Construction Condition	Good condition
Roof Type	Peaked- shingle
Roof Age	Original to building
Roof Condition	No known problems
Type of Heating System (all that apply)	Forced air- natural gas
Heating System Age	Original to building
Air Conditioning (all that apply)	Central air- entire building
Any Other Known Maintenance or Disrepair Issues	None

Apparatus Exhaust Removal	Direct connect vacuum system, connected
Underground Storage Tanks Present	No
Type of Underground Storage Tank	
Age of Underground Storage Tank	
Type of Leak Detection in Place

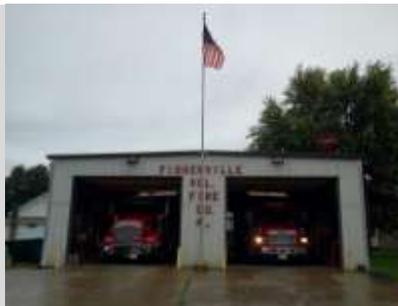
Fisherville Fire Company

Is this facility solely used for administrative offices	No
Facility used for:	Active response station
Address of Facility	16 Church St., Jackson Twp.
Facility Ownership	501(c3) Corporation Owned
Is there an outstanding mortgage on this structure?	None
Year Facility Initially Constructed	1978
Number of Major Additions or Renovations	1
Year of Major Addition/Renovation	2011

<i>Drive-through use, single unit</i>	0
<i>Drive-through capable, used with stacked parking</i>	0
Building Height	One-story
Construction Type	TYPE I-B--Fire Resistive Non-Combustible
Outside Finish	Metal siding
Unusual Construction Features	None
Overall Construction Condition	Significant finish rot or corrosion evident
Roof Type	Peaked- metal
Roof Age	Over 10 years
Roof Condition	Small, isolated leaks evident or reported
Type of Heating System (all that apply)	Forced air- fuel oil
Heating System Age	Over 10 years
Air Conditioning (all that apply)	No AC present
Any Other Known Maintenance or Disrepair Issues	Yes, Bay doors need to be replaced

Apparatus Exhaust Removal	No exhaust removal effort in place
Underground Storage Tanks Present	No
Type of Underground Storage Tank	
Age of Underground Storage Tank	
Type of Leak Detection in Place

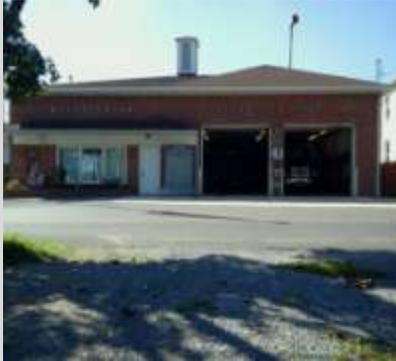
Friendship Fire Company of Bressler

Is this facility solely used for administrative offices	No
Facility used for:	Active response station, Administrative offices (HQ station)
Address of Facility	625 Main Street, Steelton Pa.
Facility Ownership	501(c3) Corporation Owned
Is there an outstanding mortgage on this structure?	None
Year Facility Initially Constructed	1936
Number of Major Additions or Renovations	1
Year of Major Addition/Renovation	1962

Building Square Feet	7,000
Apparatus Bays:	
<i>Back-in, single unit</i>	3
<i>Back-in, used with stacked parking</i>	0
<i>Drive-through use, single unit</i>	0
<i>Drive-through capable, used with stacked parking</i>	0
Building Height	One-story
Construction Type	TYPE I-B--Fire Resistive Non-Combustible
Outside Finish	Brick veneer, Masonry block
Unusual Construction Features	None
Overall Construction Condition	Good condition
Roof Type	Peaked- shingle, Flat- membrane
Roof Age	1 to 10 years
Roof Condition	No known problems
Type of Heating System (all that apply)	Steam/boiler- natural gas
Heating System Age	Over 30 years
Air Conditioning (all that apply)	Central air- living areas only
Any Other Known Maintenance or Disrepair Issues	None

Apparatus Exhaust Removal Forced air through structure, auto activation
 Underground Storage Tanks Present No
 Type of Underground Storage Tank
 Age of Underground Storage Tank
 Type of Leak Detection in Place
