*Dauphin County Gaming Advisory Board
Pennsylvania*

Comprehensive Review of Fire and
Emergency Service Resources
Final

December 2011

Comprehensive Review of Fire and Emergency Service Resources

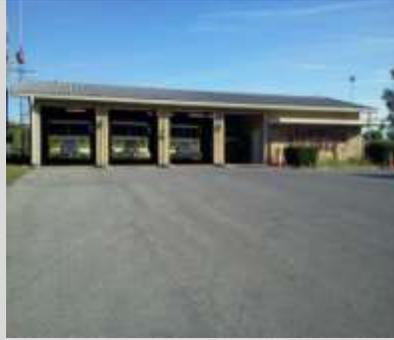
Grantville Fire Company

Is this facility solely used for administrative offices	No
Facility used for:	Active response station
Address of Facility	9803 Jonestown Rd.
Facility Ownership	501(c3) Corporation Owned
Is there an outstanding mortgage on this structure?	None
Year Facility Initially Constructed	1974
Number of Major Additions or Renovations	1
Year of Major Addition/Renovation	2000

Building Square Feet	Unknown
Apparatus Bays:	
<i>Back-in, single unit</i>	5
<i>Back-in, used with stacked parking</i>	0
<i>Drive-through use, single unit</i>	0
<i>Drive-through capable, used with stacked parking</i>	0
Building Height	One-story
Construction Type	TYPE II-A--Protected Non-Combustible
Outside Finish	Brick veneer, Masonry block
Unusual Construction Features	None
Overall Construction Condition	Worn paint or finishes, Significant finish rot or corrosion evident, Structural problems evident or reported
Roof Type	Flat- other
Roof Age	Original to building
Roof Condition	Significant leaking evident or reported
Type of Heating System (all that apply)	Forced air- fuel oil, Radiant- electric
Heating System Age	Original to building
Air Conditioning (all that apply)	Window AC unit- living areas only
Any Other Known Maintenance or Disrepair Issues	Yes, electrical problems, well water problems, poor water

Apparatus Exhaust Removal	No exhaust removal effort in place
Underground Storage Tanks Present	No
Type of Underground Storage Tank	
Age of Underground Storage Tank	
Type of Leak Detection in Place

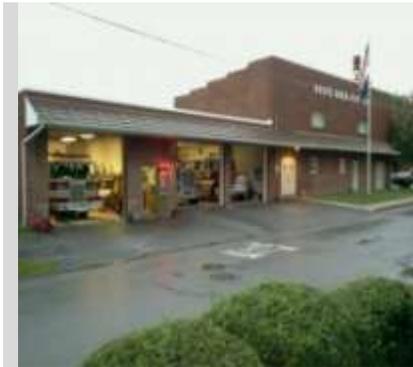
Gratz Fire Company

Is this facility solely used for administrative offices	No
Facility used for:	Active response station, Administrative offices (HQ station)
Address of Facility	202 Center Street
Facility Ownership	501(c3) Corporation Owned
Is there an outstanding mortgage on this structure?	None
Year Facility Initially Constructed	1947
Number of Major Additions or Renovations	1
Year of Major Addition/Renovation	1990

Building Square Feet	10,000
Apparatus Bays:	
<i>Back-in, single unit</i>	3
<i>Back-in, used with stacked parking</i>	0
<i>Drive-through use, single unit</i>	0
<i>Drive-through capable, used with stacked parking</i>	0
Building Height	Two-story
Construction Type	TYPE II-B--Unprotected Non-Combustible
Outside Finish	Brick veneer, Masonry block
Unusual Construction Features	None
Overall Construction Condition	Good condition, Worn paint or finishes
Roof Type	Flat - membrane
Roof Age	Over 10 years
Roof Condition	No known problems
Type of Heating System (all that apply)	Steam/boiler- fuel oil
Heating System Age	Over 20 years
Air Conditioning (all that apply)	Central air- living and administrative areas only, partial
Any Other Known Maintenance or Disrepair Issues	None

Apparatus Exhaust Removal	No exhaust removal effort in place
Underground Storage Tanks Present	No
Type of Underground Storage Tank	
Age of Underground Storage Tank	
Type of Leak Detection in Place

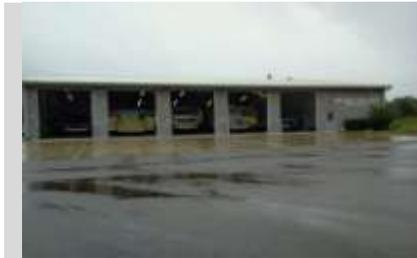
Halifax Fire Department

Is this facility solely used for administrative offices	No
Facility used for:	Active response station
Address of Facility	22 South River Rd.
Facility Ownership	501(c3) Corporation Owned
Is there an outstanding mortgage on this structure?	Yes- \$80,000.00
Year Facility Initially Constructed	1997
Number of Major Additions or Renovations	0

Building Square Feet	13,000
Apparatus Bays:	
<i>Back-in, single unit</i>	4
<i>Back-in, used with stacked parking</i>	1
<i>Drive-through use, single unit</i>	0
<i>Drive-through capable, used with stacked parking</i>	0
Building Height	One-story
Construction Type	TYPE I-B--Fire Resistive Non-Combustible
Outside Finish	Metal siding
Unusual Construction Features	None
Overall Construction Condition	Limited finish rot or corrosion evident
Roof Type	Peaked- metal
Roof Age	Original to building
Roof Condition	No known problems
Type of Heating System (all that apply)	Forced air- LP, Radiant- natural gas
Heating System Age	Original to building
Air Conditioning (all that apply)	Central air- living and administrative areas only
Any Other Known Maintenance or Disrepair Issues	None

Apparatus Exhaust Removal	Forced air through structure, manual activation
Underground Storage Tanks Present	No
Type of Underground Storage Tank	
Age of Underground Storage Tank	
Type of Leak Detection in Place

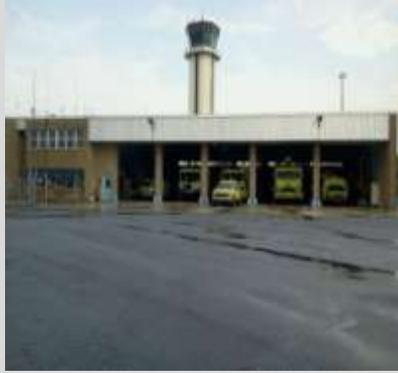
Harrisburg International Airport Fire Department

Is this facility solely used for administrative offices	No
Facility used for:	Active response station, Administrative offices (HQ station), Maintenance facility, Support/Logistics facility
Address of Facility	513 Airport Dr
Facility Ownership	Municipal Owned
Is there an outstanding mortgage on this structure?	None
Year Facility Initially Constructed	1982
Number of Major Additions or Renovations	0

Building Square Feet	12,000
Apparatus Bays:	
<i>Back-in, single unit</i>	0
<i>Back-in, used with stacked parking</i>	0
<i>Drive-through use, single unit</i>	0
<i>Drive-through capable, used with stacked parking</i>	5
Building Height	Two-story
Construction Type	TYPE II-B--Unprotected Non-Combustible
Outside Finish	Brick veneer, Masonry block
Unusual Construction Features	None
Overall Construction Condition	Good condition, Worn paint or finishes
Roof Type	Flat- membrane
Roof Age	1 to 10 years
Roof Condition	No known problems
Type of Heating System (all that apply)	Radiant- natural gas, Steam/boiler- natural gas
Heating System Age	Original to building
Air Conditioning (all that apply)	Central air- entire building
Any Other Known Maintenance or Disrepair Issues	None

Apparatus Exhaust Removal	No exhaust removal effort in place
Underground Storage Tanks Present	Yes
Type of Underground Storage Tank	Other Diesel and gas for all airport vehicles
Age of Underground Storage Tank	Over 20 years
Type of Leak Detection in Place	Fuel gauge level readings comparison

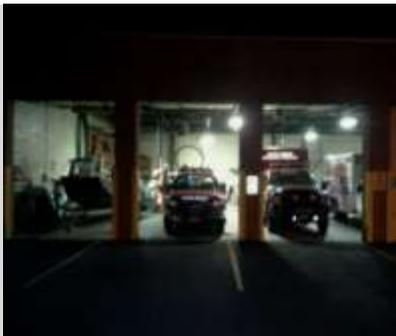
Harrisburg River Rescue and Emergency Services

Is this facility solely used for administrative offices	No
Facility used for	Active response station, Training or drill facility, Maintenance facility
Address of Facility	1119 South Cameron St.
Facility Ownership	501(c3) Corporation Owned
Is there an outstanding mortgage on this structure?	None
Year Facility Initially Constructed	1954
Number of Major Additions or Renovations	0

<i>Back-in, used with stacked parking</i>	3
<i>Drive-through use, single unit</i>	0
<i>Drive-through capable, used with stacked parking</i>	0
Building Height	One-story
Construction Type	TYPE II-A--Protected Non-Combustible
Outside Finish	Masonry block
Unusual Construction Features	None
Overall Construction Condition	Worn paint or finishes
Roof Type	Flat- roll roofing
Roof Age	1 to 10 years
Roof Condition	No known problems
Type of Heating System (all that apply)	Forced air- natural gas
Heating System Age	Original to building
Air Conditioning (all that apply)	Central air- living areas only
Any Other Known Maintenance or Disrepair Issues	None

Apparatus Exhaust Removal	No exhaust removal effort in place
Underground Storage Tanks Present	No
Type of Underground Storage Tank	
Age of Underground Storage Tank	
Type of Leak Detection in Place

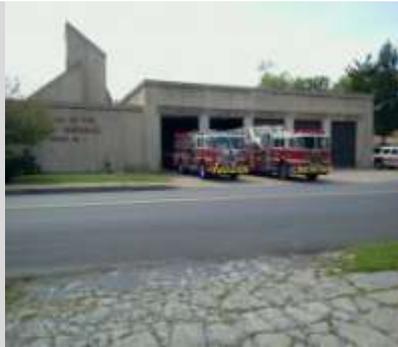
Harrisburg Bureau of Fire Station 1

Is this facility solely used for administrative offices	No
Facility used for:	Active response station, Training or drill facility
Address of Facility	1820 North 6th
Facility Ownership	Municipal Owned
Is there an outstanding mortgage on this structure?	None
Year Facility Initially Constructed	1981
Number of Major Additions or Renovations	0

Neighborhood	
Building and Property Adaptable if Future Expansion Needed	Expansion need unlikely
Adequate Staff and Visitor Parking	Parking is adequate
Safety Features	
Automatic Fire Sprinklers Present	None
Fire Sprinkler System Type	
Alarm Systems Present	Monitored smoke/heat alarms
SCBA Compressor System Present	Yes
Back-Up Generator Present	Yes, with auto transfer switch
Generator Fuel Type and Source	Diesel fuel, local tank
Environmental Features	
Apparatus Exhaust Removal	Direct connect vacuum system, disconnected
Underground Storage Tanks Present	No
Type of Underground Storage Tank	
Age of Underground Storage Tank	
Type of Leak Detection in Place	
Station Staff Facilities and Features	
Adequate Space for Working On or Around Apparatus	Space around apparatus is adequate
Apparatus Room Accommodates Working on Small Equipment	Adequate space
Personnel Can Move Quickly and Easily to Apparatus for Response	Yes

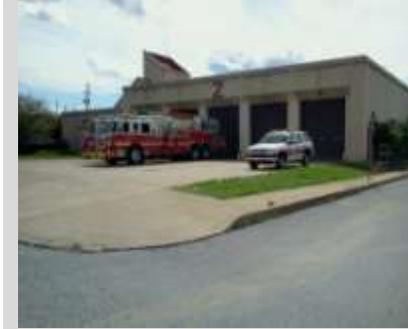
Harrisburg Bureau of Fire Station 2

Is this facility solely used for administrative offices	No
Facility used for:	Active response station
Address of Facility	9 South 13th St
Facility Ownership	Municipal Owned
Is there an outstanding mortgage on this structure?	None
Year Facility Initially Constructed	1981
Number of Major Additions or Renovations	0

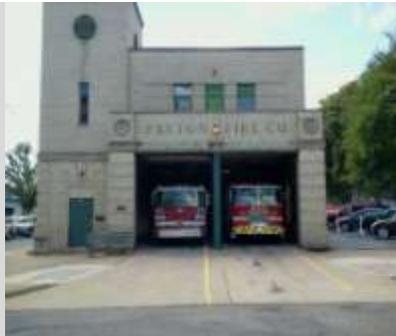
Harrisburg Bureau of Fire Station 6

Is this facility solely used for administrative offices	No
Facility used for:	Active response station
Address of Facility	332 South Second St
Facility Ownership	Municipal Owned
Is there an outstanding mortgage on this structure?	None
Year Facility Initially Constructed	1937
Number of Major Additions or Renovations	1
Year of Major Addition/Renovation	1985

Building Square Feet	Unknown
Apparatus Bays:	
<i>Back-in, single unit</i>	2
<i>Back-in, used with stacked parking</i>	0
<i>Drive-through use, single unit</i>	0
<i>Drive-through capable, used with stacked parking</i>	0
Building Height	Two-story
Construction Type	TYPE II-B--Unprotected Non-Combustible
Outside Finish	Brick veneer, Masonry block
Unusual Construction Features	None
Overall Construction Condition	Worn paint or finishes, Limited finish rot or corrosion evident, Significant finish rot or corrosion evident Structural problems evident or reported
Roof Type	Flat- membrane
Roof Age	Age unknown
Roof Condition	Significant leaking evident or reported
Type of Heating System (all that apply)	Forced air- natural gas
Heating System Age	Age unknown
Air Conditioning (all that apply)	Central air- living areas only
Any Other Known Maintenance or Disrepair Issues	Yes The station has a history of flooding. Ceiling plaster is falling.

Overall Size of Facility Adequate for Current Use	No
Apparatus Exit	Traffic sightlines compromised
Building and Property Blend Well with Neighborhood	Yes
Building and Property Adaptable if Future Expansion Needed	No
Adequate Staff and Visitor Parking	Staff parking is inadequate, Visitor parking is inadequate

Apparatus Exhaust Removal	Direct connect vacuum system, connected
Underground Storage Tanks Present	No
Type of Underground Storage Tank	
Age of Underground Storage Tank	
Type of Leak Detection in Place

Adequate Space for Working On or Around Apparatus	Space around apparatus cramped and movement is limited, Limited space for working at rear of apparatus, Apparatus parking is impeded due to inadequate space
Apparatus Room Accommodates Working on Small Equipment	Space is small and limited

Personnel Can Move Quickly and Easily to Apparatus for Response	Inadequate space
Adequate Space for Cooking and Eating	No routine residential staffing occurs
Adequate Space for Local Company Training and Drills	Inadequate space
Are Compromises Necessary for Two-Gender Staffing	No
Two-Gender Compromises	
Adequate Space for Personal Hygiene	Inadequate space
Adequate Space for Sleeping	Inadequate space
Adequate Space for Storage	Inadequate space
Identify any Additional Operational Compromises Made by Staff or Crew to Compensate for Facility Inadequacies	This station is old in poor condition. Often flooding in the basement. Basement not used for anything. Single pane windows leak
List Facility Features	Day room/lounge, Kitchen, Male dormitory

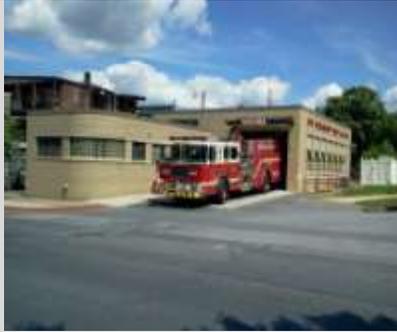
Harrisburg Bureau of Fire Station 8

Is this facility solely used for administrative offices	No
Facility used for:	Active response station
Address of Facility	9 South 13th
Facility Ownership	Municipal Owned
Is there an outstanding mortgage on this structure?	None
Year Facility Initially Constructed	1954
Number of Major Additions or Renovations	0

Building Square Feet	Unknown
Apparatus Bays:	
<i>Back-in, single unit</i>	0
<i>Back-in, used with stacked parking</i>	0
<i>Drive-through use, single unit</i>	1
<i>Drive-through capable, used with stacked parking</i>	0
Building Height	One-story
Construction Type	TYPE II-B--Unprotected Non-Combustible
Outside Finish	Brick veneer, Masonry block
Unusual Construction Features	None
Overall Construction Condition	Worn paint or finishes
Roof Type	Flat- membrane
Roof Age	1 to 10 years
Roof Condition	No known problems
Type of Heating System (all that apply)	Forced air- natural gas
Heating System Age	1 to 10 years
Air Conditioning (all that apply)	Central air- living areas only
Any Other Known Maintenance or Disrepair Issues	None

Apparatus Exhaust Removal	Direct connect vacuum system, connected
Underground Storage Tanks Present	No
Type of Underground Storage Tank	
Age of Underground Storage Tank	
Type of Leak Detection in Place

Adequate Space for Working On or Around Apparatus	Space around apparatus cramped and movement is limited
Apparatus Room Accommodates Working on Small Equipment	Space is small and limited
Personnel Can Move Quickly and Easily to Apparatus for Response	Compromised Lack of lighting and steps from lower level dorm
Adequate Space for Cooking and Eating	Yes
Adequate Space for Local Company Training and Drills	Inadequate space
Are Compromises Necessary for Two-Gender Staffing	No
Two-Gender Compromises	
Adequate Space for Personal Hygiene	Inadequate space
Adequate Space for Sleeping	Inadequate space
Adequate Space for Storage	Inadequate space
Identify any Additional Operational Compromises Made by Staff or Crew to Compensate for Facility Inadequacies	
List Facility Features	Day room/lounge, Kitchen, Coed dormitory, Dedicated exercise/workout area

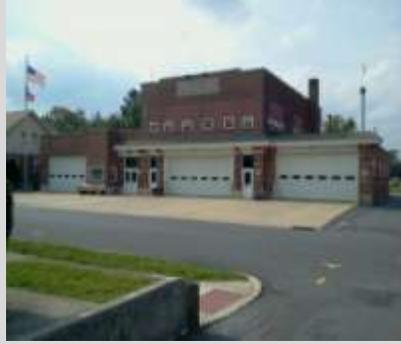
Hershey Fire Department

Is this facility solely used for administrative offices	No
Facility used for	Active response station
Address of Facility	21 West Caracas Ave.
Facility Ownership	501(c3) Corporation Owned
Is there an outstanding mortgage on this structure?	None
Year Facility Initially Constructed	1928
Number of Major Additions or Renovations	2
Year of Major Addition/Renovation	1955, 1976

Building Square Feet	11,300
Apparatus Bays:	
<i>Back-in, single unit</i>	5
<i>Back-in, used with stacked parking</i>	1
<i>Drive-through use, single unit</i>	0
<i>Drive-through capable, used with stacked parking</i>	0
Building Height	Two-story
Construction Type	TYPE II-A--Protected Non-Combustible
Outside Finish	Brick veneer, Masonry block
Unusual Construction Features	None
Overall Construction Condition	Good condition, Worn paint or finishes
Roof Type	Flat- membrane
Roof Age	Over 10 years
Roof Condition	No known problems
Type of Heating System (all that apply)	Forced air- natural gas, Steam/boiler- fuel oil
Heating System Age	Over 20 years
Air Conditioning (all that apply)	Central air- living and administrative areas only, partial, Window AC unit- living and administrative areas only
Any Other Known Maintenance or Disrepair Issues	None

Overall Size of Facility Adequate for Current Use	Yes
Apparatus Exit	Exit to traffic flow safe and unimpeded
Building and Property Blend Well with Neighborhood	Yes
Building and Property Adaptable if Future Expansion Needed	No
Adequate Staff and Visitor Parking	Staff parking is inadequate, Visitor parking is inadequate

Apparatus Exhaust Removal	Vehicle mounted system
Underground Storage Tanks Present	No
Type of Underground Storage Tank	
Age of Underground Storage Tank	
Type of Leak Detection in Place

Adequate Space for Working On or Around Apparatus	Space around apparatus is adequate
Apparatus Room Accommodates Working on Small Equipment	Adequate space
Personnel Can Move Quickly and Easily to Apparatus for Response	Yes
Adequate Space for Cooking and Eating	No routine residential staffing occurs
Adequate Space for Local Company Training and Drills	Yes
Are Compromises Necessary for Two-Gender Staffing	No routine residential staffing occurs
Two-Gender Compromises	Single shower facility or area
Adequate Space for Personal Hygiene	Yes
Adequate Space for Sleeping	Not intended for sleep accommodation
Adequate Space for Storage	Yes
Identify any Additional Operational Compromises Made by Staff or Crew to Compensate for Facility Inadequacies	More room needed due to large membership
List Facility Features	Separate watch room/station office, Station officer private office, Administrative/support offices, Communications/dispatch, Day room/lounge, Classroom for >10, Training library, Quiet/study room, Shower/locker room(s), Dedicated exercise/workout area, Turnout gear extraction washer, SCBA filling station

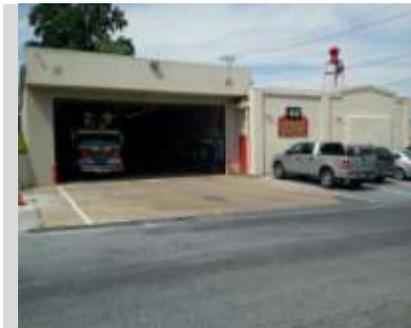
Lawnton Fire Company

Is this facility solely used for administrative offices	No
Facility used for:	Active response station
Address of Facility	52 South 46th. Street
Facility Ownership	501(c3) Corporation Owned
Is there an outstanding mortgage on this structure?	Yes- \$ 50,000.00
Year Facility Initially Constructed	1935
Number of Major Additions or Renovations	2
Year of Major Addition/Renovation	1981, 2000

Building Square Feet	6,800
Apparatus Bays:	
<i>Back-in, single unit</i>	2
<i>Back-in, used with stacked parking</i>	0
<i>Drive-through use, single unit</i>	0
<i>Drive-through capable, used with stacked parking</i>	0
Building Height	One-story
Construction Type	TYPE II-B--Unprotected Non-Combustible
Outside Finish	Brick veneer, Metal siding, Masonry block
Unusual Construction Features	None
Overall Construction Condition	Good condition, Worn paint or finishes
Roof Type	Flat- membrane
Roof Age	Over 20 years
Roof Condition	Small, isolated leaks evident or reported
Type of Heating System (all that apply)	Forced air- natural gas
Heating System Age	1 to 10 years
Air Conditioning (all that apply)	Central air- living areas only
Any Other Known Maintenance or Disrepair Issues	Yes, History of basement flooding

Overall Size of Facility Adequate for Current Use	Yes
Apparatus Exit	Signalization would be helpful, but not present
Building and Property Blend Well with Neighborhood	Yes
Building and Property Adaptable if Future Expansion Needed	No
Adequate Staff and Visitor Parking	Staff parking is inadequate, Visitor parking is inadequate

Apparatus Exhaust Removal	Direct connect vacuum system, disconnected
Underground Storage Tanks Present	No
Type of Underground Storage Tank	
Age of Underground Storage Tank	
Type of Leak Detection in Place

Adequate Space for Local Company Training and Drills	Yes
Are Compromises Necessary for Two-Gender Staffing	No routine residential staffing occurs
Two-Gender Compromises	
Adequate Space for Personal Hygiene	Compromised No Showers
Adequate Space for Sleeping	Not intended for sleep accommodation
Adequate Space for Storage	Inadequate space
Identify any Additional Operational Compromises Made by Staff or Crew to Compensate for Facility Inadequacies	No bunk room/shower. Lack of kitchen space..
List Facility Features	Station officer private office, Day room/lounge, Classroom for >10, Turnout gear extraction washer, SCBA filling station

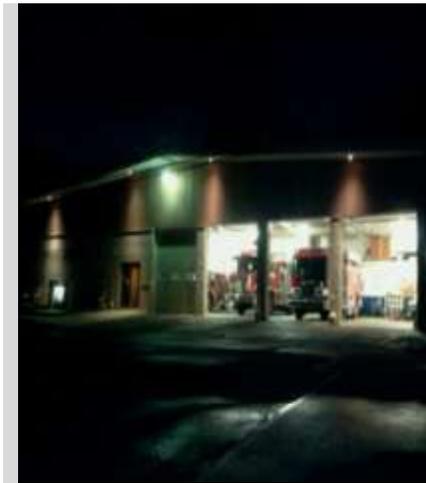
Liberty Hose Company No. 1 Williamstown

Is this facility solely used for administrative offices	No
Facility used for:	Active response station
Address of Facility	225 West Broad Street
Facility Ownership	501(c3) Corporation Owned
Is there an outstanding mortgage on this structure?	None
Year Facility Initially Constructed	1976
Number of Major Additions or Renovations	0

Building Square Feet	8,000
Apparatus Bays:	
<i>Back-in, single unit</i>	4
<i>Back-in, used with stacked parking</i>	0
<i>Drive-through use, single unit</i>	0
<i>Drive-through capable, used with stacked parking</i>	0
Building Height	One-story
Construction Type	TYPE I-B--Fire Resistive Non-Combustible
Outside Finish	Brick veneer, Masonry block
Unusual Construction Features	None
Overall Construction Condition	Good condition
Roof Type	Flat- membrane
Roof Age	1 to 10 years
Roof Condition	No known problems
Type of Heating System (all that apply)	Forced air- LP, Forced air- fuel oil, Radiant- electric
Heating System Age	1 to 10 years
Air Conditioning (all that apply)	Central air- living and administrative areas only, partial
Any Other Known Maintenance or Disrepair Issues	None

Apparatus Exhaust Removal	No exhaust removal effort in place
Underground Storage Tanks Present	No
Type of Underground Storage Tank	
Age of Underground Storage Tank	
Type of Leak Detection in Place

Adequate Space for Working On or Around Apparatus	Space around apparatus is adequate
Apparatus Room Accommodates Working on Small Equipment	Work must be conducted outdoors
Personnel Can Move Quickly and Easily to Apparatus for Response	Yes
Adequate Space for Cooking and Eating	Yes
Adequate Space for Local Company Training and Drills	Yes
Are Compromises Necessary for Two-Gender Staffing	No routine residential staffing occurs
Two-Gender Compromises	
Adequate Space for Personal Hygiene	Compromised No showers
Adequate Space for Sleeping	Not intended for sleep accommodation
Adequate Space for Storage	Yes
Identify any Additional Operational Compromises Made by Staff or Crew to Compensate for Facility Inadequacies	None
List Facility Features	Separate watch room/station office, Station officer private office, Kitchen, Conference room(s), Classroom for >10, Training library

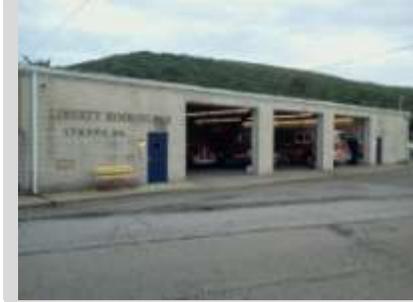
Liberty Hose Company No. 2 of Lykens

Is this facility solely used for administrative offices	No
Facility used for:	Active response station, Administrative offices (HQ station)
Address of Facility	553 South Second Street
Facility Ownership	501(c3) Corporation Owned
Is there an outstanding mortgage on this structure?	None
Year Facility Initially Constructed	1976
Number of Major Additions or Renovations	0

Building Square Feet	5,000
Apparatus Bays:	
<i>Back-in, single unit</i>	3
<i>Back-in, used with stacked parking</i>	0
<i>Drive-through use, single unit</i>	0
<i>Drive-through capable, used with stacked parking</i>	0
Building Height	One-story
Construction Type	TYPE II-B--Unprotected Non-Combustible
Outside Finish	Brick veneer, Masonry block
Unusual Construction Features	None
Overall Construction Condition	Worn paint or finishes
Roof Type	Flat- membrane
Roof Age	Over 10 years
Roof Condition	No known problems
Type of Heating System (all that apply)	Forced air- LP
Heating System Age	1 to 10 years
Air Conditioning (all that apply)	Central air- living and administrative areas only
Any Other Known Maintenance or Disrepair Issues	None

Underground Storage Tanks Present No
 Type of Underground Storage Tank
 Age of Underground Storage Tank
 Type of Leak Detection in Place

<p>Adequate Space for Working On or Around Apparatus</p> <p>Apparatus Room Accommodates Working on Small Equipment</p> <p>Personnel Can Move Quickly and Easily to Apparatus for Response</p> <p>Adequate Space for Cooking and Eating</p> <p>Adequate Space for Local Company Training and Drills</p> <p>Are Compromises Necessary for Two-Gender Staffing</p> <p>Two-Gender Compromises</p> <p>Adequate Space for Personal Hygiene</p> <p>Adequate Space for Sleeping</p> <p>Adequate Space for Storage</p> <p>Identify any Additional Operational Compromises Made by Staff or Crew to Compensate for Facility Inadequacies</p> <p>List Facility Features</p>	<p>Space around apparatus cramped and movement is limited, Limited space for working at rear of apparatus, Apparatus parking is impeded due to inadequate space</p> <p>Space is small and limited</p> <p>Inadequate space</p> <p>No routine residential staffing occurs</p> <p>Inadequate space</p> <p>No routine residential staffing occurs</p> <p>Compromised No showers</p> <p>Not intended for sleep accommodation</p> <p>Inadequate space</p> <p>None</p> <p>Day room/lounge, SCBA filling station</p>

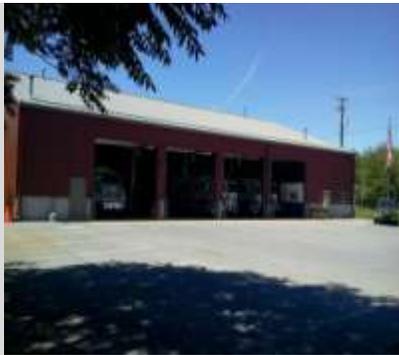
Linglestown Fire Company

Is this facility solely used for administrative offices	No
Facility used for:	Active response station, Administrative offices (HQ station)
Address of Facility	5901 Linglestown Road
Facility Ownership	501(c3) Corporation Owned
Is there an outstanding mortgage on this structure?	Mortgage Status Uncertain
Year Facility Initially Constructed	1991
Number of Major Additions or Renovations	2
Year of Major Addition/Renovation	2011

Unusual Construction Features	None
Overall Construction Condition	Good condition
Roof Type	Peaked- metal
Roof Age	1 to 10 years
Roof Condition	No known problems
Type of Heating System (all that apply)	Forced air- electric
Heating System Age	Original to building
Air Conditioning (all that apply)	Central air- entire building
Any Other Known Maintenance or Disrepair Issues	None

Apparatus Exhaust Removal	Direct connect vacuum system, connected
Underground Storage Tanks Present	No
Type of Underground Storage Tank	
Age of Underground Storage Tank	
Type of Leak Detection in Place

List Facility Features Separate watch room/station office, Administrative/support offices, Day room/lounge, Kitchen, Classroom for >10, Coed dormitory, Shower/locker room(s), Turnout gear extraction washer, SCBA filling station

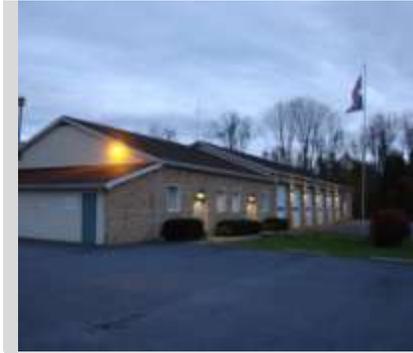
Londonderry Township Fire Company

Is this facility solely used for administrative offices No
 Facility used for: Active response station, Administrative offices (HQ station), Training or drill facility, Maintenance facility, Support/Logistics facility
 Address of Facility 2655 Foxianna Rd. Middletown, PA 17057
 Facility Ownership? 501(c3) Corporation Owned
 Is there an outstanding mortgage on this structure? Yes- \$1.1 Million
 Year Facility Initially Constructed 1964
 Number of Major Additions or Renovations 2
 Year of Major Additions/Renovations 1982, 2009

Building Square Feet 17,100
 Apparatus Bays:
 Back-in, single unit 6
 Back-in, used with stacked parking 0
 Drive-through use, single unit 0
 Drive-through capable, used with stacked parking 0
 Building Height One-story
 Construction Type TYPE III-A--Protected Combustible (one-hour rating)
 Outside Finish Masonry block
 Unusual Construction Features None
 Overall Construction Condition Good condition
 Roof Type Peaked-shingle, Flat- membrane
 Roof Age 1 to 10 years
 Roof Condition No known problems
 Type of Heating System (all that apply) Forced air- LP
 Heating System Age 1 to 10 years
 Air Conditioning (all that apply) Central air- living and administrative areas only
 Any Other Known Maintenance or Disrepair Issues None

Apparatus Exhaust Removal	No exhaust removal effort in place
Underground Storage Tanks Present	No
Type of Underground Storage Tank	
Age of Underground Storage Tank	
Type of Leak Detection in Place

Adequate Space for Working On or Around Apparatus	Space around apparatus is adequate
Apparatus Room Accommodates Working on Small Equipment	Adequate space
Personnel Can Move Quickly and Easily to Apparatus for Response	Yes
Adequate Space for Cooking and Eating	Yes
Adequate Space for Local Company Training and Drills	Yes
Are Compromises Necessary for Two-Gender Staffing	No
Two-Gender Compromises	
Adequate Space for Personal Hygiene	Yes
Adequate Space for Sleeping	Yes
Adequate Space for Storage	Yes
Identify any Additional Operational Compromises Made by Staff or Crew to Compensate for Facility Inadequacies	
List Facility Features	Separate watch room/station office, Station officer private office, Administrative/support offices, Day room/lounge, Kitchen, Conference room(s), Classroom for >10, Training library, Quiet/study room, Male dormitory, Female dormitory, Shower/locker room(s), Dedicated exercise/workout area, Turnout gear extraction washer, SCBA filling station

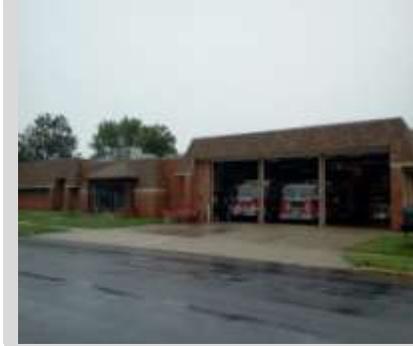
Middletown Fire Department

Is this facility solely used for administrative offices	No
Facility used for:	Active response station, Administrative offices (HQ station)
Address of Facility	1410 Adelia
Facility Ownership	501(c3) Corporation Owned
Is there an outstanding mortgage on this structure?	None
Year Facility Initially Constructed	1974
Number of Major Additions or Renovations	0

Building Square Feet	7,000
Apparatus Bays:	
<i>Back-in, single unit</i>	2
<i>Back-in, used with stacked parking</i>	0
<i>Drive-through use, single unit</i>	1
<i>Drive-through capable, used with stacked parking</i>	0
Building Height	One-story
Construction Type	TYPE II-B--Unprotected Non-Combustible
Outside Finish	Brick veneer, Masonry block
Unusual Construction Features	None
Overall Construction Condition	Good condition
Roof Type	Flat- membrane
Roof Age	Over 10 years
Roof Condition	Small, isolated leaks evident or reported
Type of Heating System (all that apply)	Forced air- natural gas, Forced air- electric
Heating System Age	Over 10 years
Air Conditioning (all that apply)	Central air- living and administrative areas only
Any Other Known Maintenance or Disrepair Issues	None

Overall Size of Facility Adequate for Current Use	No
Apparatus Exit	Exit to traffic flow safe and unimpeded
Building and Property Blend Well with Neighborhood	Yes
Building and Property Adaptable if Future Expansion Needed	Yes
Adequate Staff and Visitor Parking	Parking is adequate, Visitor parking is inadequate

Adequate Space for Working On or Around Apparatus	Space around apparatus cramped and movement is limited, Limited space for working at rear of apparatus
Apparatus Room Accommodates Working on Small Equipment	Adequate space
Personnel Can Move Quickly and Easily to Apparatus for Response	Yes
Adequate Space for Cooking and Eating	Inadequate space
Adequate Space for Local Company Training and Drills	Inadequate space
Are Compromises Necessary for Two-Gender Staffing	No routine residential staffing occurs
Two-Gender Compromises	
Adequate Space for Personal Hygiene	Inadequate space
Adequate Space for Sleeping	Not intended for sleep accommodation
Adequate Space for Storage	Inadequate space
Identify any Additional Operational Compromises Made by Staff or Crew to Compensate for Facility Inadequacies	Some equipment is stored at another location. No training room, no dorms, no bathrooms with showers and locker room.

List Facility Features	Station officer private office, Administrative/support offices, Day room/lounge, Kitchen, Turnout gear extraction washer, SCBA filling station

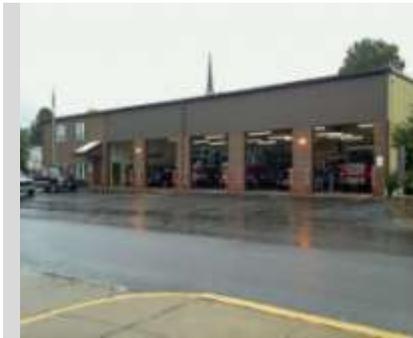
Millersburg Fire Company

Is this facility solely used for administrative offices	No
Facility used for:	Active response station
Address of Facility	325 Center Street, Millersburg Pa. 17061
Facility Ownership	501(c3) Corporation Owned
Is there an outstanding mortgage on this structure?	None
Year Facility Initially Constructed	1982
Number of Major Additions or Renovations	0

Overall Construction Condition	Good condition
Roof Type	Peaked- metal
Roof Age	1 to 10 years
Roof Condition	No known problems
Type of Heating System (all that apply)	Forced air- LP, Radiant- natural gas
Heating System Age	Original to building
Air Conditioning (all that apply)	Central air- living and administrative areas only
Any Other Known Maintenance or Disrepair Issues	None

Apparatus Exhaust Removal	No exhaust removal effort in place
Underground Storage Tanks Present	No
Type of Underground Storage Tank	
Age of Underground Storage Tank	
Type of Leak Detection in Place

Inadequacies
 List Facility Features Station officer private office, Communications/dispatch, Day room/lounge, Kitchen, Conference room(s), Classroom for >10, Shower/locker room(s), SCBA filling station

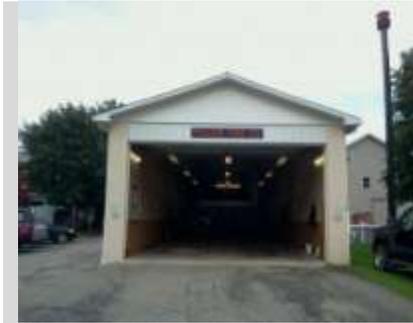
Pillow Fire Company

Is this facility solely used for administrative offices No
 Facility used for: (select all that apply, major functions only) Active response station
 Address of Facility 193 Market Street --- PO Box 452
 Facility Ownership? 501(c3) Corporation Owned
 Is there an outstanding mortgage on this structure? None
 Year Facility Initially Constructed 1936
 Number of Major Additions or Renovations 2
 Year of Major Addition/Renovation 1955, 1985

Building Square Feet 2,700
 Apparatus Bays:
Back-in, single unit 0
Back-in, used with stacked parking 2
Drive-through use, single unit 0
Drive-through capable, used with stacked parking 0
 Building Height Two-story
 Construction Type TYPE II-B--Unprotected Non-Combustible
 Outside Finish Masonry block
 Unusual Construction Features None
 Overall Construction Condition Good condition
 Roof Type Peaked- shingle
 Roof Age Over 10 years
 Roof Condition No known problems
 Type of Heating System (all that apply) Steam/boiler- fuel oil
 Heating System Age Over 20 years
 Air Conditioning (all that apply) No AC present
 Any Other Known Maintenance or Disrepair Issues Yes Needs windows

Overall Size of Facility Adequate for Current Use Yes
 Apparatus Exit Exit to traffic flow safe and unimpeded
 Building and Property Blend Well with Neighborhood Yes
 Building and Property Adaptable if Future Expansion Needed No
 Adequate Staff and Visitor Parking Staff parking is inadequate, Visitor parking is inadequate

Apparatus Exhaust Removal	No exhaust removal effort in place
Underground Storage Tanks Present	No
Type of Underground Storage Tank	
Age of Underground Storage Tank	
Type of Leak Detection in Place

Adequate Space for Working On or Around Apparatus	Space around apparatus cramped and movement is limited, Limited space for working at rear of apparatus, Apparatus parking is impeded due to inadequate space
Apparatus Room Accommodates Working on Small Equipment	Work must be conducted outdoors
Personnel Can Move Quickly and Easily to Apparatus for Response	Inadequate space
Adequate Space for Cooking and Eating	No routine residential staffing occurs
Adequate Space for Local Company Training and Drills	Yes
Are Compromises Necessary for Two-Gender Staffing	No routine residential staffing occurs
Two-Gender Compromises	
Adequate Space for Personal Hygiene	Inadequate space
Adequate Space for Sleeping	Not intended for sleep accommodation
Adequate Space for Storage	Inadequate space
Identify any Additional Operational Compromises Made by Staff or Crew to Compensate for Facility Inadequacies	Limited space
List Facility Features	Classroom for >10,SCBA filling station

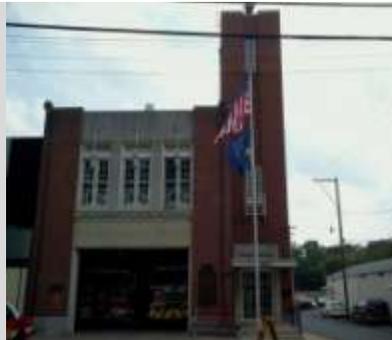
Paxtang Fire Company

Is this facility solely used for administrative offices	No
Facility used for:	Active response station, Support/Logistics facility
Address of Facility	3423 Derry St
Facility Ownership	Municipal Owned
Is there an outstanding mortgage on this structure?	None
Year Facility Initially Constructed	1932
Number of Major Additions or Renovations	0

Building Square Feet	Unknown
Apparatus Bays:	
<i>Back-in, single unit</i>	1
<i>Back-in, used with stacked parking</i>	0
<i>Drive-through use, single unit</i>	0
<i>Drive-through capable, used with stacked parking</i>	0
Building Height	Two-story
Construction Type	TYPE I-B--Fire Resistive Non-Combustible
Outside Finish	Brick veneer, Masonry block
Unusual Construction Features	None
Overall Construction Condition	Structural problems evident or reported
Roof Type	Peaked- shingle, Flat- membrane
Roof Age	Over 10 years
Roof Condition	Small, isolated leaks evident or reported
Type of Heating System (all that apply)	Forced air- natural gas, Radiant- electric
Heating System Age	Original to building
Air Conditioning (all that apply)	Central air- living areas only
Any Other Known Maintenance or Disrepair Issues	None

Apparatus Exhaust Removal	No exhaust removal effort in place
Underground Storage Tanks Present	No
Type of Underground Storage Tank	
Age of Underground Storage Tank	
Type of Leak Detection in Place

Adequate Space for Local Company Training and Drills	Inadequate space
Are Compromises Necessary for Two-Gender Staffing	No routine residential staffing occurs
Two-Gender Compromises	
Adequate Space for Personal Hygiene	Inadequate space
Adequate Space for Sleeping	Inadequate space
Adequate Space for Storage	Inadequate space
Identify any Additional Operational Compromises Made by Staff or Crew to Compensate for Facility Inadequacies	Old building with many limitations in space and function
List Facility Features	Separate watch room/station office, Day room/lounge

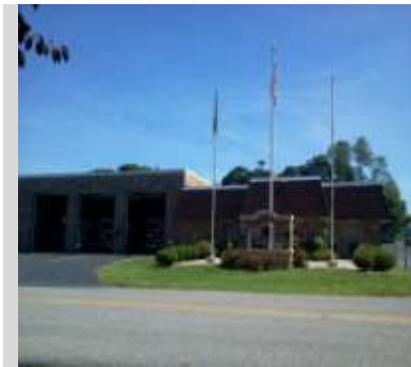
Paxtonia Fire Company

Is this facility solely used for administrative offices	No
Facility used for:	Active response station, Administrative offices (HQ station), Training or drill facility
Address of Facility	125 South Johnson St.
Facility Ownership	501(c3) Corporation Owned
Is there an outstanding mortgage on this structure?	Yes- \$580,000.00
Year Facility Initially Constructed	1977
Number of Major Additions or Renovations	1
Year of Major Addition/Renovation	2009

Adequate Space for Working On or Around Apparatus	Space around apparatus is adequate
Apparatus Room Accommodates Working on Small Equipment	Adequate space
Personnel Can Move Quickly and Easily to Apparatus for Response	Yes
Adequate Space for Cooking and Eating	Yes
Adequate Space for Local Company Training and Drills	Yes
Are Compromises Necessary for Two-Gender Staffing	No
Two-Gender Compromises	
Adequate Space for Personal Hygiene	Yes
Adequate Space for Sleeping	Yes
Adequate Space for Storage	Yes
Identify any Additional Operational Compromises Made by Staff or Crew to Compensate for Facility Inadequacies	None
List Facility Features	Station officer private office, Administrative/support offices, Day room/lounge, Kitchen, Conference room(s), Classroom for >10, Training library, Quiet/study room, Male dormitory, Shower/locker room(s), Separate turnout gear room, Turnout gear extraction washer, SCBA filling station

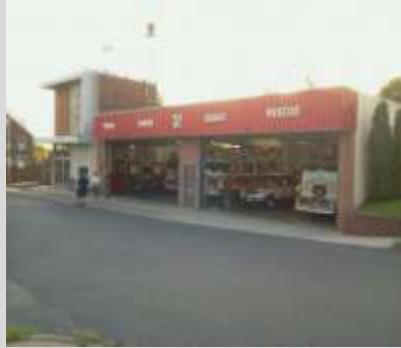
Progress Fire Company

Is this facility solely used for administrative offices	No
Facility used for:	Active response station, Administrative offices (HQ station)
Address of Facility	3440 Maple Street
Facility Ownership	501(c3) Corporation Owned
Is there an outstanding mortgage on this structure?	Yes- Amount? \$77,000.00
Year Facility Initially Constructed	1958
Number of Major Additions or Renovations	2
Year of Major Addition/Renovation	1984, 2009

Adequate Space for Working On or Around Apparatus	Space around apparatus is adequate, Limited space for working at rear of apparatus
Apparatus Room Accommodates Working on Small Equipment	Adequate space
Personnel Can Move Quickly and Easily to Apparatus for Response	Yes
Adequate Space for Cooking and Eating	Yes
Adequate Space for Local Company Training and Drills	Yes
Are Compromises Necessary for Two-Gender Staffing	Yes
Two-Gender Compromises	Single toilet facilities, Single shower facility or area, No private dressing area
Adequate Space for Personal Hygiene	Inadequate space
Adequate Space for Sleeping	Inadequate space
Adequate Space for Storage	Inadequate space
Identify any Additional Operational Compromises Made by Staff or Crew to Compensate for Facility Inadequacies	Insufficient space for residential firefighters.
List Facility Features	Separate watch room/station office, Day room/lounge, Kitchen, Classroom for >10, Training library, Coed dormitory, Shower/locker room(s), Dedicated exercise/workout area, SCBA filling station

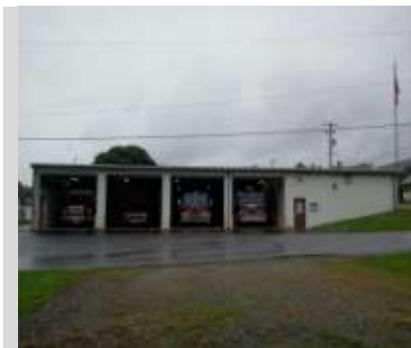
Reliance Hose Company No. 1 of Elizabethville

Is this facility solely used for administrative offices	No
Facility used for:	Active response station, Training or drill facility
Address of Facility	333 West Main Street
Facility Ownership	501(c3) Corporation Owned
Is there an outstanding mortgage on this structure?	None
Year Facility Initially Constructed	1992
Number of Major Additions or Renovations	0

Adequate Space for Sleeping	Not intended for sleep accommodation
Adequate Space for Storage	Yes
Identify any Additional Operational Compromises Made by Staff or Crew to Compensate for Facility Inadequacies	Insufficient office space and training, meeting room
List Facility Features	Kitchen, Classroom for >10, Shower/locker room(s), SCBA filling station

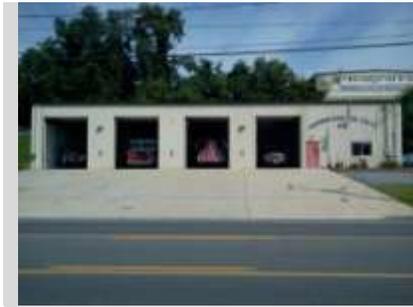
Reliance Hose Company No. 1 of Rutherford Heights

Is this facility solely used for administrative offices	No
Facility used for:	Active response station, Administrative offices (HQ station)
Address of Facility	6600 Derry Street
Facility Ownership	501(c3) Corporation Owned
Is there an outstanding mortgage on this structure?	None
Year Facility Initially Constructed	1991
Number of Major Additions or Renovations	0

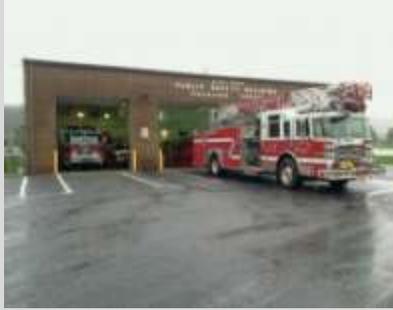
Adequate Space for Working On or Around Apparatus	Space around apparatus cramped and movement is limited, Limited space for working at rear of apparatus
Apparatus Room Accommodates Working on Small Equipment	Space is small and limited
Personnel Can Move Quickly and Easily to Apparatus for Response	Yes
Adequate Space for Cooking and Eating	Yes
Adequate Space for Local Company Training and Drills	Yes
Are Compromises Necessary for Two-Gender Staffing	Yes
Two-Gender Compromises	Single toilet facilities, Single shower facility or area, No private dressing area
Adequate Space for Personal Hygiene	Yes
Adequate Space for Sleeping	Yes
Adequate Space for Storage	Yes
Identify any Additional Operational Compromises Made by Staff or Crew to Compensate for Facility Inadequacies	Lack of exercise room
List Facility Features	Administrative/support offices, Day room/lounge, Kitchen, Conference room(s), Classroom for >10, Coed dormitory, Shower/locker room(s), Turnout gear extraction washer

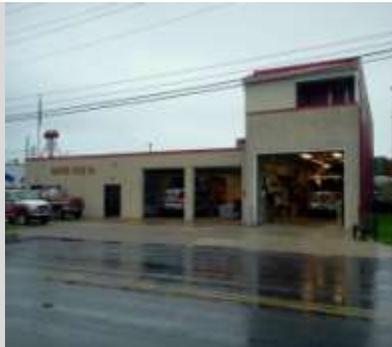
Rescue Fire Company of Susquehanna Township Station 2

Is this facility solely used for administrative offices	No
Facility used for:	Active response station, Administrative offices (HQ station)
Address of Facility	3701 North 6th. Street
Facility Ownership	501(c3) Corporation Owned
Is there an outstanding mortgage on this structure?	None
Year Facility Initially Constructed	1951
Number of Major Additions or Renovations	1
Year of Major Addition/Renovation	1976

Drive-through use, single unit 0
Drive-through capable, used with stacked parking 0
 Building Height Two-story
 Construction Type TYPE III-A--Protected Combustible (one-hour rating)
 Outside Finish Masonry block
 Unusual Construction Features None
 Overall Construction Condition Worn paint or finishes
 Roof Type Flat- membrane
 Roof Age 1 to 10 years
 Roof Condition No known problems
 Type of Heating System (all that apply) Steam/boiler- natural gas
 Heating System Age 1 to 10 years
 Air Conditioning (all that apply) Central air- living and administrative areas only, partial
 Any Other Known Maintenance or Disrepair Issues None

Apparatus Exhaust Removal Vehicle mounted system
 Underground Storage Tanks Present No
 Type of Underground Storage Tank
 Age of Underground Storage Tank
 Type of Leak Detection in Place

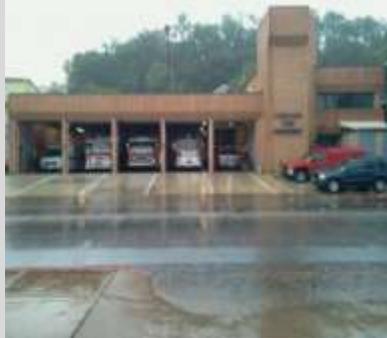
Steelton Fire Department

Is this facility solely used for administrative offices	No
Facility used for:	Active response station, Administrative offices (HQ station), Training or drill facility, Support/Logistics facility
Address of Facility	185 North Front Street
Facility Ownership	501(c3) Corporation Owned
Is there an outstanding mortgage on this structure?	None
Year Facility Initially Constructed	1985
Number of Major Additions or Renovations	0

Building Square Feet	8,000
Apparatus Bays:	
<i>Back-in, single unit</i>	4
<i>Back-in, used with stacked parking</i>	1
<i>Drive-through use, single unit</i>	0
<i>Drive-through capable, used with stacked parking</i>	0
Building Height	Two-story
Construction Type	TYPE III-B--Unprotected Combustible
Outside Finish	Brick veneer, Masonry block
Unusual Construction Features	None
Overall Construction Condition	Structural problems evident or reported
Roof Type	Flat- membrane
Roof Age	1 to 10 years
Roof Condition	No known problems
Type of Heating System (all that apply)	Forced air- natural gas
Heating System Age	Over 20 years
Air Conditioning (all that apply)	Central air- living and administrative areas only
Any Other Known Maintenance or Disrepair Issues	Yes Surface water around foundation, cinder block deterioration, concrete floors cracking, front apron breaking

Apparatus Exhaust Removal	No exhaust removal effort in place
Underground Storage Tanks Present	Yes
Type of Underground Storage Tank	Diesel fuel
Age of Underground Storage Tank	Over 20 years
Type of Leak Detection in Place	Manual level readings comparison

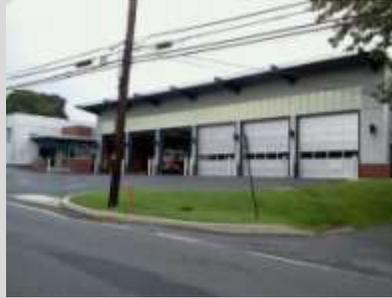
Swatara Township Volunteer Fire Company No. 1

Is this facility solely used for administrative offices	No
Facility used for:	Active response station, Administrative offices (HQ station), Training or drill facility
Address of Facility	1201 Ober St.
Facility Ownership	Municipal Owned
Is there an outstanding mortgage on this structure?	None
Year Facility Initially Constructed	1963
Number of Major Additions or Renovations	2
Year of Major Addition/Renovation	1993, 2005

Building Square Feet	Unknown
Apparatus Bays:	
<i>Back-in, single unit</i>	0
<i>Back-in, used with stacked parking</i>	0
<i>Drive-through use, single unit</i>	0
<i>Drive-through capable, used with stacked parking</i>	6
Building Height	One-story
Construction Type	TYPE II-A--Protected Non-Combustible
Outside Finish	Metal siding, Masonry block
Unusual Construction Features	None
Overall Construction Condition	Good condition
Roof Type	Flat- membrane, Flat- other
Roof Age	Over 10 years
Roof Condition	No known problems
Type of Heating System (all that apply)	Forced air- natural gas
Heating System Age	Over 10 years
Air Conditioning (all that apply)	Central air- entire building
Any Other Known Maintenance or Disrepair Issues	None

Apparatus Exhaust Removal Direct connect vacuum system, connected
 Underground Storage Tanks Present No
 Type of Underground Storage Tank
 Age of Underground Storage Tank
 Type of Leak Detection in Place

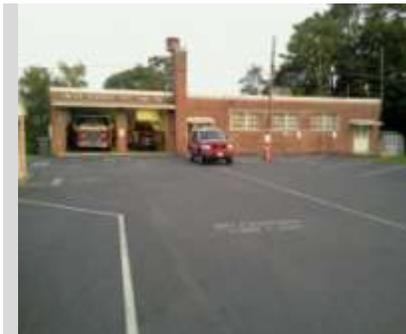
Union Deposit Volunteer Fire Company

Is this facility solely used for administrative offices No
 Facility used for: Active response station
 Address of Facility 10 West Main Street
 Facility Ownership 501(c3) Corporation Owned
 Is there an outstanding mortgage on this structure? None
 Year Facility Initially Constructed 1951
 Number of Major Additions or Renovations 0

Building Square Feet	4,000
Apparatus Bays:	
<i>Back-in, single unit</i>	2
<i>Back-in, used with stacked parking</i>	0
<i>Drive-through use, single unit</i>	0
<i>Drive-through capable, used with stacked parking</i>	0
Building Height	One-story
Construction Type	TYPE III-B--Unprotected Combustible
Outside Finish	Brick veneer, Masonry block
Unusual Construction Features	None
Overall Construction Condition	Worn paint or finishes, Significant finish rot or corrosion evident, Structural problems evident or reported
Roof Type	Flat- roll roofing
Roof Age	Over 30 years
Roof Condition	Significant leaking evident or reported
Type of Heating System (all that apply)	Steam/boiler- fuel oil
Heating System Age	Original to building
Air Conditioning (all that apply)	Central air- living areas only
Any Other Known Maintenance or Disrepair Issues	Major cracks on concrete floor, block walls are cracking. Concrete breaking up at apparatus doors. Not ADA compliant. Basement has continuous water leaks affection the foundation.

Overall Size of Facility Adequate for Current Use	No
Apparatus Exit	Signalization would be helpful but not present
Building and Property Blend Well with Neighborhood	No
Building and Property Adaptable if Future Expansion Needed	No
Adequate Staff and Visitor Parking	Staff parking is inadequate, Visitor parking is inadequate

Apparatus Exhaust Removal	Forced air through structure, auto activation
Underground Storage Tanks Present	No
Type of Underground Storage Tank	
Age of Underground Storage Tank	
Type of Leak Detection in Place

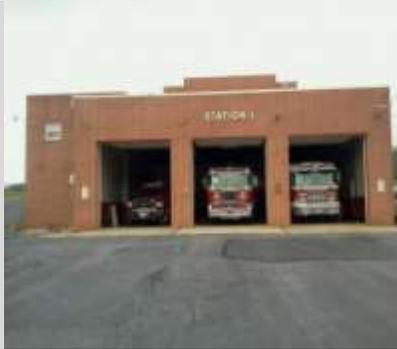
West Hanover Township Fire Company

Is this facility solely used for administrative offices	No
Facility used for:	Active response station, Administrative offices (HQ station)
Address of Facility	628 Walnut Ave.
Facility Ownership	501(c3) Corporation Owned
Is there an outstanding mortgage on this structure?	None
Year Facility Initially Constructed	1953
Number of Major Additions or Renovations	4
Year of Major Addition/Renovation	1967, 1975 x 2, 1978

Building Square Feet	9,682
Apparatus Bays:	
<i>Back-in, single unit</i>	1
<i>Back-in, used with stacked parking</i>	1
<i>Drive-through use, single unit</i>	0
<i>Drive-through capable, used with stacked parking</i>	0
Building Height	Two-story
Construction Type	TYPE II-B--Unprotected Non-Combustible
Outside Finish	Brick veneer, Masonry block
Unusual Construction Features	None
Overall Construction Condition	Good condition
Roof Type	Peaked- other
Roof Age	Over 10 years
Roof Condition	No known problems
Type of Heating System (all that apply)	Forced air- LP, Steam/boiler- fuel oil
Heating System Age	1 to 10 years

Air Conditioning (all that apply)	Central air- living and administrative areas only
Any Other Known Maintenance or Disrepair Issues	None
Design Features	
Overall Size of Facility Adequate for Current Use	No
Apparatus Exit	Exit to traffic flow safe and unimpeded
Building and Property Blend Well with Neighborhood	Yes
Building and Property Adaptable if Future Expansion Needed	Yes
Adequate Staff and Visitor Parking	Parking is adequate
Safety Features	
Automatic Fire Sprinklers Present	None
Fire Sprinkler System Type	
Alarm Systems Present	Local smoke detection only
SCBA Compressor System Present	Yes
Back-Up Generator Present	Yes, with auto transfer switch
Generator Fuel Type and Source	LP, local tank
Environmental Features	
Apparatus Exhaust Removal	No exhaust removal effort in place
Underground Storage Tanks Present	No
Type of Underground Storage Tank	
Age of Underground Storage Tank	
Type of Leak Detection in Place

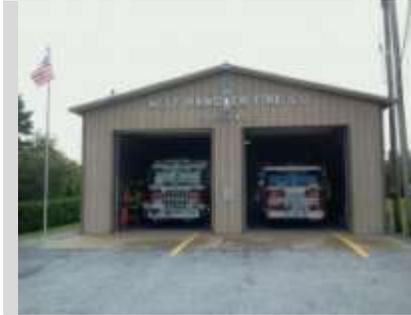
West Hanover Township Fire Company Station 2

Is this facility solely used for administrative offices	No
Facility used for:	Active response station
Address of Facility	545 Hershey Rd.
Facility Ownership	501(c3) Corporation Owned
Is there an outstanding mortgage on this structure?	Yes- \$100,000
Year Facility Initially Constructed	1983
Number of Major Additions or Renovations	1
Year of Major Addition/Renovation	2010

Building Square Feet	2,880
Apparatus Bays:	
<i>Back-in, single unit</i>	2
<i>Back-in, used with stacked parking</i>	0
<i>Drive-through use, single unit</i>	0
<i>Drive-through capable, used with stacked parking</i>	0
Building Height	One-story
Construction Type	TYPE II-A--Protected Non-Combustible
Outside Finish	Metal siding
Unusual Construction Features	None
Overall Construction Condition	Good condition
Roof Type	Peaked- metal
Roof Age	1 to 10 years
Roof Condition	No known problems
Type of Heating System (all that apply)	Forced air- LP
Heating System Age	1 to 10 years
Air Conditioning (all that apply)	Central air- entire building
Any Other Known Maintenance or Disrepair Issues	None

Apparatus Exhaust Removal No exhaust removal effort in place
 Underground Storage Tanks Present No
 Type of Underground Storage Tank
 Age of Underground Storage Tank
 Type of Leak Detection in Place

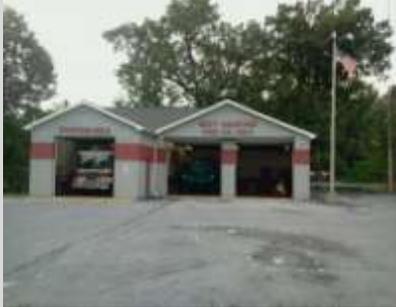
West Hanover Township Fire Company Station 3

Is this facility solely used for administrative offices No
 Facility used for: Active response station
 Address of Facility 1296 Piketown Rd.
 Facility Ownership 501(c3) Corporation Owned
 Is there an outstanding mortgage on this structure? None
 Year Facility Initially Constructed 1976
 Number of Major Additions or Renovations 1
 Year of Major Addition/Renovation 2000

Outside Finish	Masonry block
Unusual Construction Features	None
Overall Construction Condition	Good condition
Roof Type	Peaked- shingle
Roof Age	Over 10 years
Roof Condition	No known problems
Type of Heating System (all that apply)	Forced air- fuel oil
Heating System Age	Over 10 years
Air Conditioning (all that apply)	No AC present
Any Other Known Maintenance or Disrepair Issues	None

Apparatus Exhaust Removal	No exhaust removal effort in place
Underground Storage Tanks Present	No
Type of Underground Storage Tank	
Age of Underground Storage Tank	
Type of Leak Detection in Place

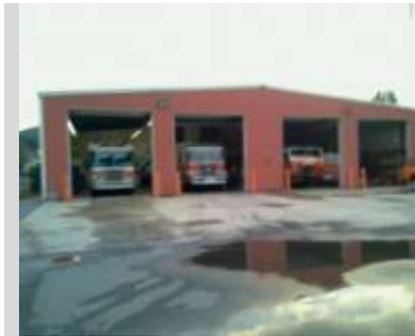
Wiconisco Fire Engine Company No. 1

Is this facility solely used for administrative offices	No
Facility used for:	Active response station, Administrative offices (HQ station)
Address of Facility	387 Arch Street
Facility Ownership	501(c3) Corporation Owned
Is there an outstanding mortgage on this structure?	None
Year Facility Initially Constructed	1988
Number of Major Additions or Renovations	0

Building Square Feet	16,000
Apparatus Bays:	
<i>Back-in, single unit</i>	3
<i>Back-in, used with stacked parking</i>	1
<i>Drive-through use, single unit</i>	0
<i>Drive-through capable, used with stacked parking</i>	0
Building Height	One-story
Construction Type	TYPE I-A--Fire Resistive Non-combustible
Outside Finish	Metal siding
Unusual Construction Features	None
Overall Construction Condition	Good condition
Roof Type	Peaked- metal
Roof Age	Original to building
Roof Condition	No known problems
Type of Heating System (all that apply)	Steam/boiler- fuel oil
Heating System Age	Original to building
Air Conditioning (all that apply)	No AC present
Any Other Known Maintenance or Disrepair Issues	None

Apparatus Exhaust Removal	No exhaust removal effort in place
Underground Storage Tanks Present	No
Type of Underground Storage Tank	
Age of Underground Storage Tank	
Type of Leak Detection in Place

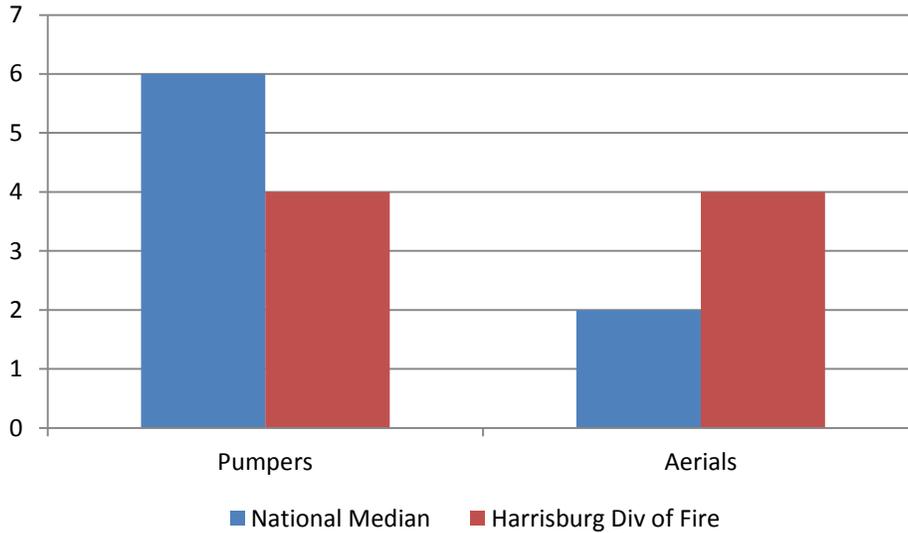
Figure 51: HFD Comparison of Physical Resources

The following figure illustrates how Harrisburg Fire Department (the only department within this particular category) compares against other departments of similar population.

Based on the benchmark data available, when compared to departments serving similar populations, HFD has two fewer engines/pumpers and two more aerial apparatus than the national median. It is worth noting here, however, that several of HFD’s aerial apparatus are considered ‘quints’ that could function as engines if necessary. The next figure applies to the study departments serving a population between 10,000 and 24,999, which includes Colonial Park, Hershey, Linglestown, Paxtonia, Progress, and Rescue Fire Co. – Susquehanna.

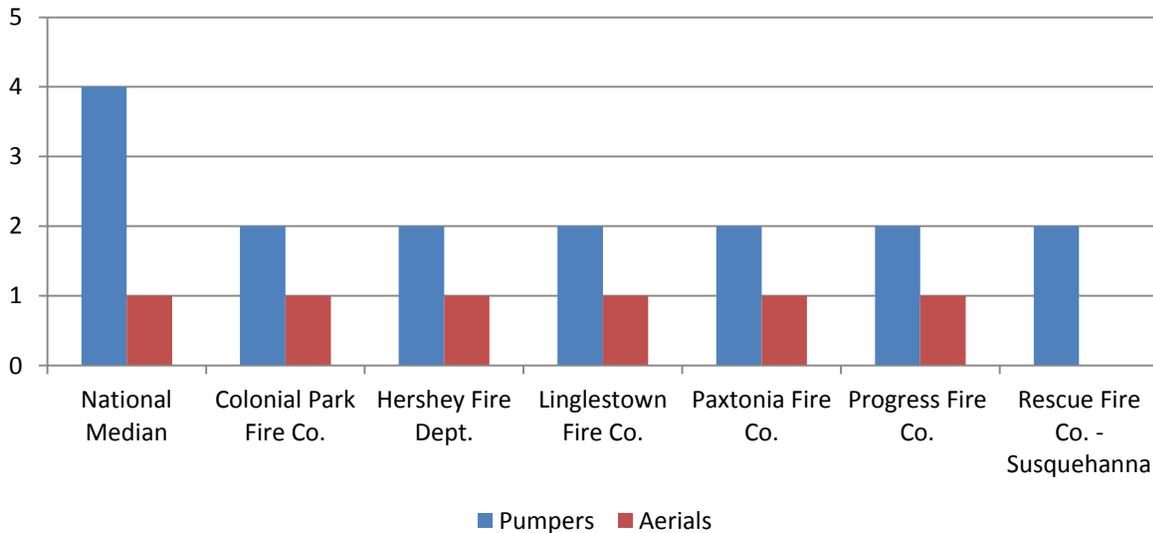
Figure 52: Comparison of Physical Resources (10,000-24,999 Population)

Based on the benchmark data available, when compared to departments serving similar populations, each of the study departments within this category have two fewer engines/pumpers than the national median. Rescue Fire Company – Susquehanna does not operate an aerial apparatus, but this specialized piece of equipment should be deployed based on risk rather than population. The next figure applies to the study departments serving populations between 5,000 and 9,999, which includes Dauphin-Middle Paxton, Grantville, Halifax, Londonderry, Lower Swatara, Middletown, Millersburg, Reliance/Rutherford, Steelton, Swatara, Union Deposit, and West Hanover.

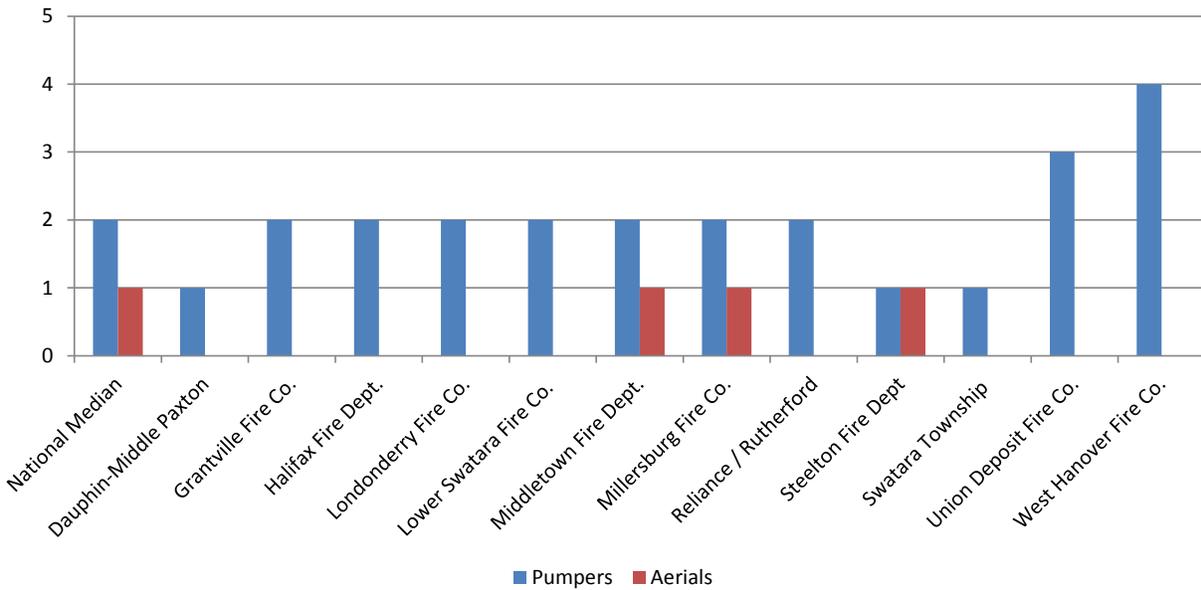
Figure 53: Comparison of Physical Resources (5,000-9,999 Population)

Based on the benchmark data available, when compared to departments serving similar populations, Dauphin-Middle, Steelton, and Swatara have one fewer engines/pumpers than the national median. Union Deposit and West Hanover both operate more engines/pumpers than the national median. Only Middletown, Millersburg, and Steelton operate aerial apparatus; this specialized piece of equipment should be deployed based on risk rather than population. The next figure applies to the study departments serving populations between 2,500 and 4,999, which includes Chambers Hill, Chemical Fire Company - Hummelstown, Lawnton, Penbrook, and Reliance Hose Company – Elizabethville.
