*Dauphin County Gaming Advisory Board
Pennsylvania*

Comprehensive Review of Fire and
Emergency Service Resources
Final

December 2011

Comprehensive Review of Fire and Emergency Service Resources

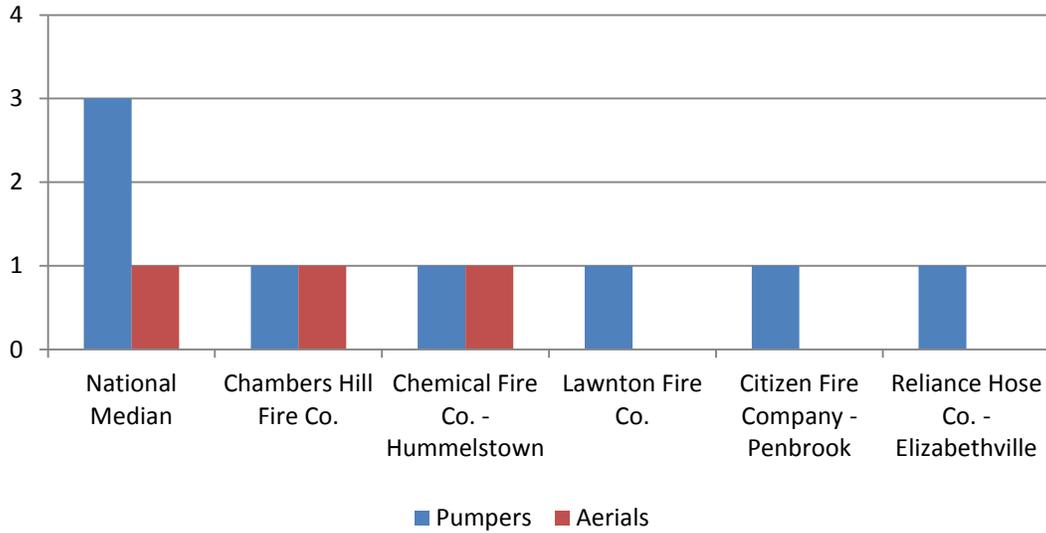
Figure 54: Comparison of Physical Resources (2,500-4,999 Population)

Based on the benchmark data available, when compared to departments serving similar populations, each of the study departments in this category have two fewer engines than the national median. Lawnton, Citizens Fire Company – Penbrook, and Reliance Hose Co. – Elizabethville do not operate aerial apparatus, but this specialized piece of equipment should be deployed based on risk rather than population. The next figure applies to the study departments serving populations under 2,500, which includes Berrysburg, Carsonville, Citizens, Edgemont, Fisherville, Bressler, Gratz, Liberty Hose – Lykens, Liberty Hose – Williamstown, Paxtang, Pillow, and Wiconisco.

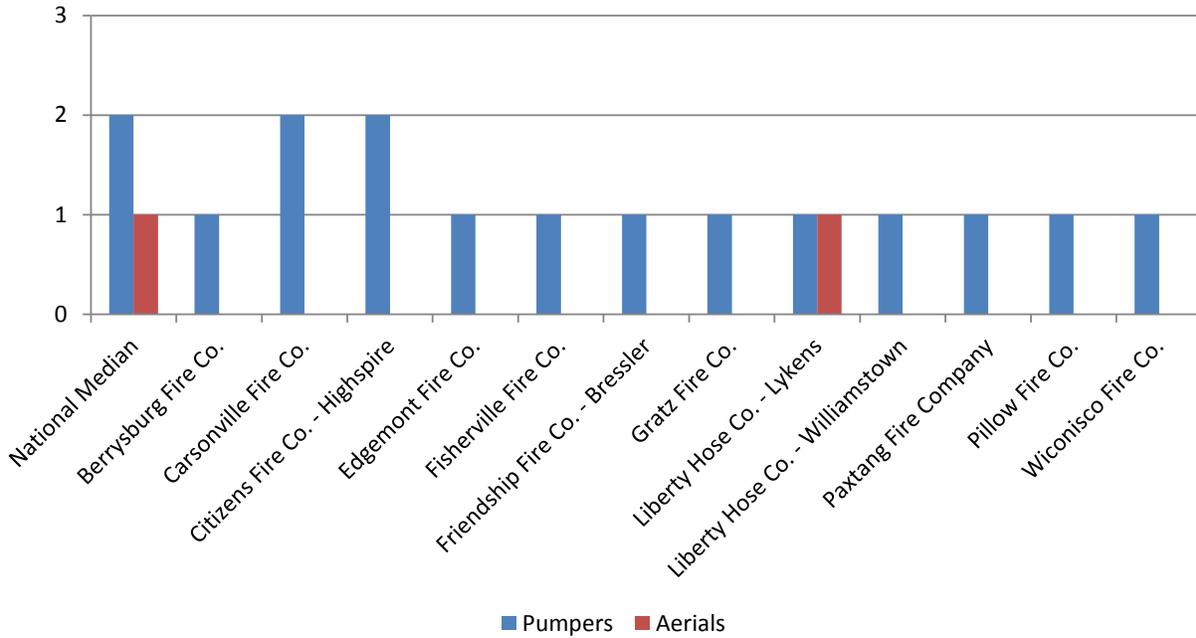
Figure 55: Comparison of Physical Resources (Below 2,500 Population)

Based on the benchmark data available, when compared to departments serving similar populations, each of the study departments in this category except for Carsonville and Citizens have one fewer engines than the national median. Only Liberty Hose – Lykens operates an aerial apparatus, but this specialized piece of equipment should be deployed based on risk rather than population.
